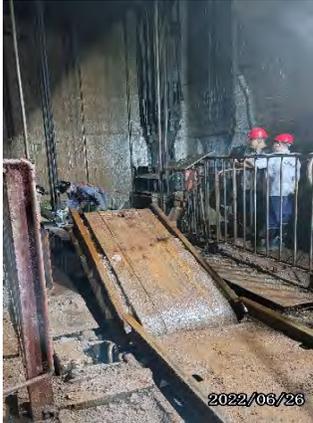
149	GX-B1598/21-2-22077	2022. 7. 11	实测钢丝绳有效截面积 损失百分比最大为 1.62%，小于5% 为正常 。

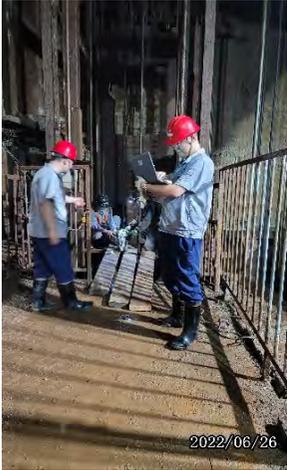
153	GX-B1598/21-2-22081	2022. 7. 11	实测钢丝绳有效截面积 损失百分比最大为 2.90%，小于5% 为正常 。

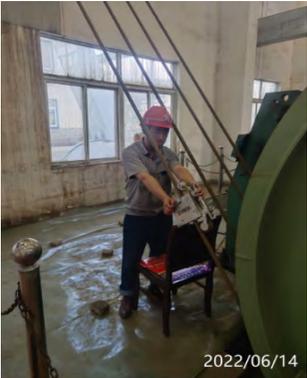
154	GX-B1598/21-2-22109	2022. 7. 11	实测钢丝绳有效截面积 损失百分比最大为 0.97%，小于5% 为正常 。

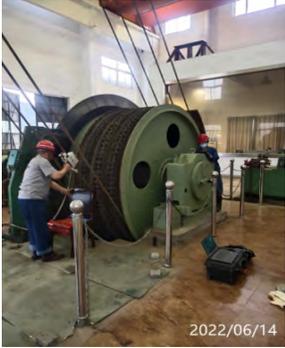
155	GX-B1598/21-2-22110	2022. 7. 11	实测钢丝绳有效截面积损失百分比最大为0.29%，小于5% 为正常。

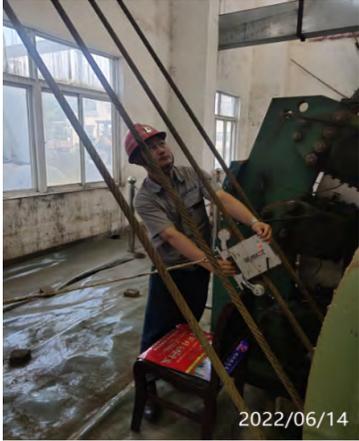
156	GX-B1598/21-2-22111	2022. 7. 11	实测钢丝绳有效截面积损失百分比最大为0.60%，小于5% 为正常。

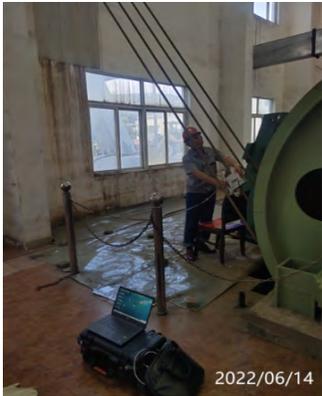
157	GX-B1598/21-2-22112	2022.7.11	实测钢丝绳有效截面积损失百分比最大为1.00%，小于5% 为正常。
