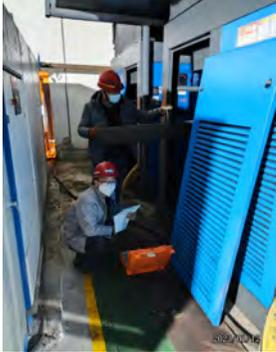
序号	报告编号	发布日期	结论	影像资料
293	GX-B1306/21-2-23005	2023/1/29	除上述问题外，其余所检项目合格。

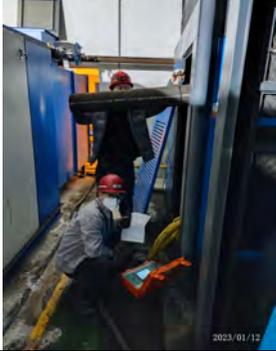
A photograph showing two workers in a control room. They are wearing hard hats and safety glasses. One worker is standing and looking at a large blue panel, while the other is kneeling and working on a piece of equipment. The date stamp '2023/1/29' is visible in the bottom right corner.
294	GX-B1306/21-2-23006	2023/1/29	除上述问题外，其余所检项目合格。

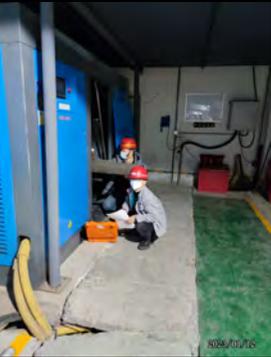
295	GX-B1306/21-2-23007	2023/1/29	除上述问题外，其余所检项目合格。

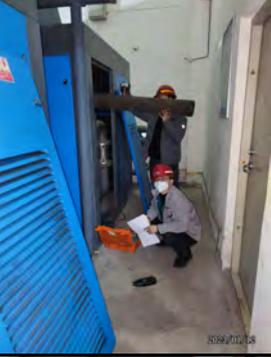
296	GX-B1306/21-2-23008	2023/1/29	除上述问题外，其余所检项目合格。

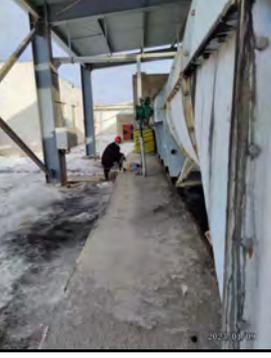
297	GX-B1310/21-2-23006	2023/1/29	未发现超过Φ2mm当量直径的缺陷。

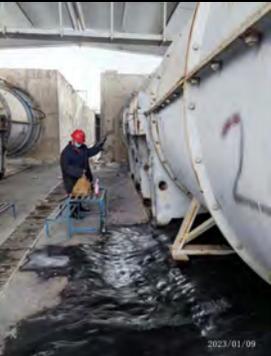
298	GX-B1310/21-2-23007	2023/1/29	未发现超过 $\Phi 2\text{mm}$ 当量直径的缺陷。

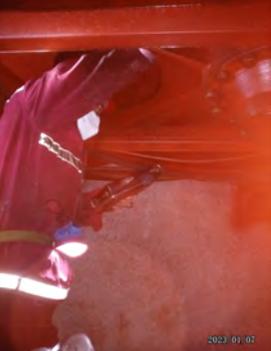
299	GX-B1310/21-2-23008	2023/1/29	未发现超过 $\Phi 2\text{mm}$ 当量直径的缺陷。

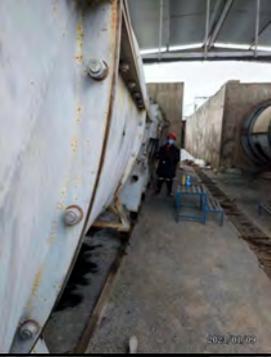
305	GX-B1428/21-2-23006	2023/1/29	无缺陷迹痕显示。

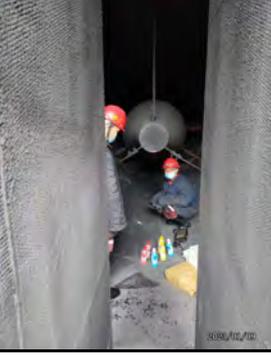
306	GX-B1428/21-2-23007	2023/1/29	无缺陷迹痕显示。

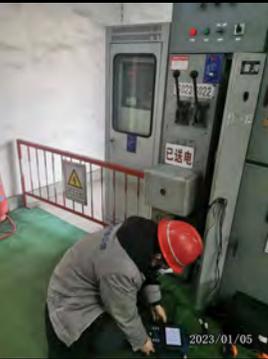
313	GX-B1404/20-2-23001	2323. 1. 31	<p>所检电网谐波电压总谐波畸变率、各次谐波电压含有率、谐波电流符合GB/T 14549-1993 《电能质量 公用电网谐波》要求。</p>

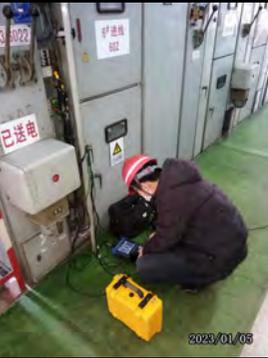
314	GX-B1404/20-2-23002	2323. 1. 31	<p>所检电网谐波电压总谐波畸变率、各次谐波电压含有率、谐波电流符合GB/T 14549-1993 《电能质量 公用电网谐波》要求。</p>
