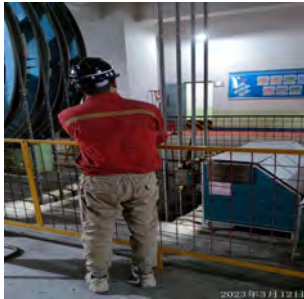
46	GX-B1598/21-5-23007	2023/3/17	<p>实测钢丝绳有效截面积损失百分比最大为1.38%，小于5%为正常。</p>

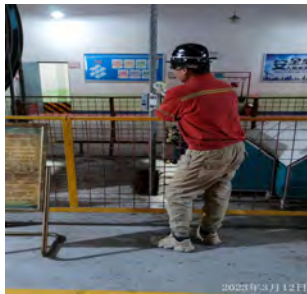
47	GX-B1598/21-5-23008	2023/3/17	<p>实测钢丝绳有效截面积损失百分比最大为0.54%，小于5%为正常。</p>

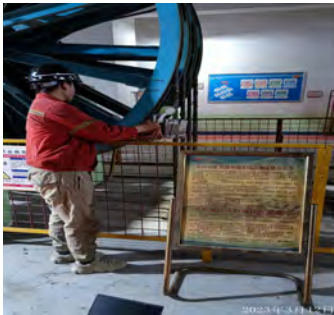
48	GX-B1598/21-5-23009	2023/3/17	<p>实测钢丝绳有效截面积损失百分比最大为1.91%，小于5%为正常。</p>
