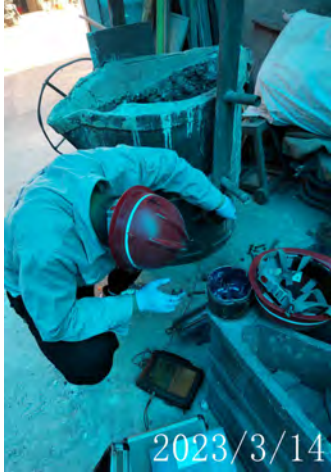
序号	报告编号	发布日期	结论	影像资料
80	GX-B1310/21-5-23049	2023/3/18	符合标准要求。

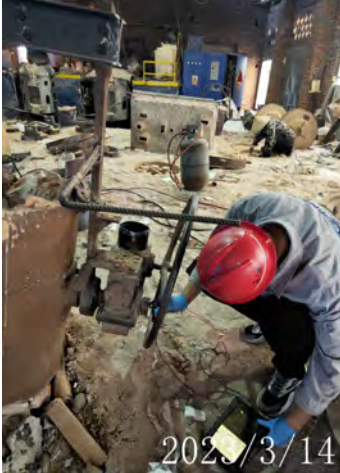
81	GX-B1310/21-5-23050	2023/3/18	符合标准要求。

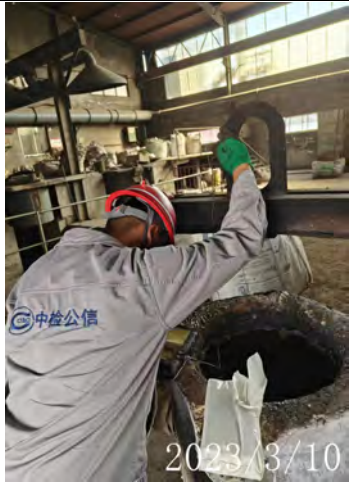
82	GX-B1310/21-5-23038	2023/3/18	符合标准要求。

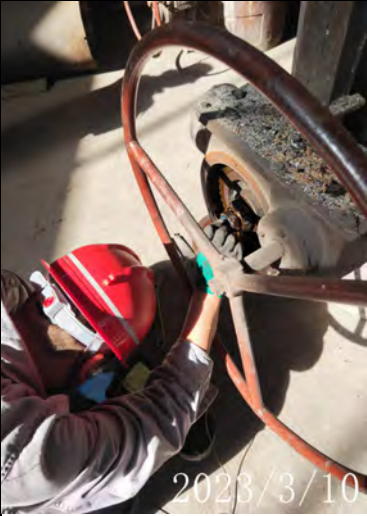
83	GX-B1310/21-5-23039	2023/3/18	符合标准要求。

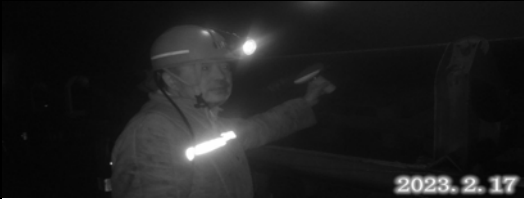
96	GX-B1416/22-5-23012	2023. 3. 31	合格

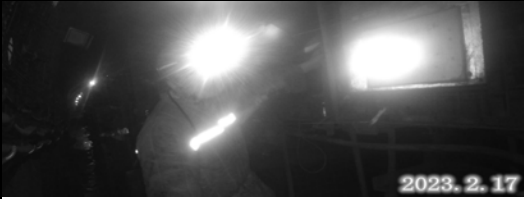
97	GX-B1416/22-5-23013	2023. 3. 31	合格
