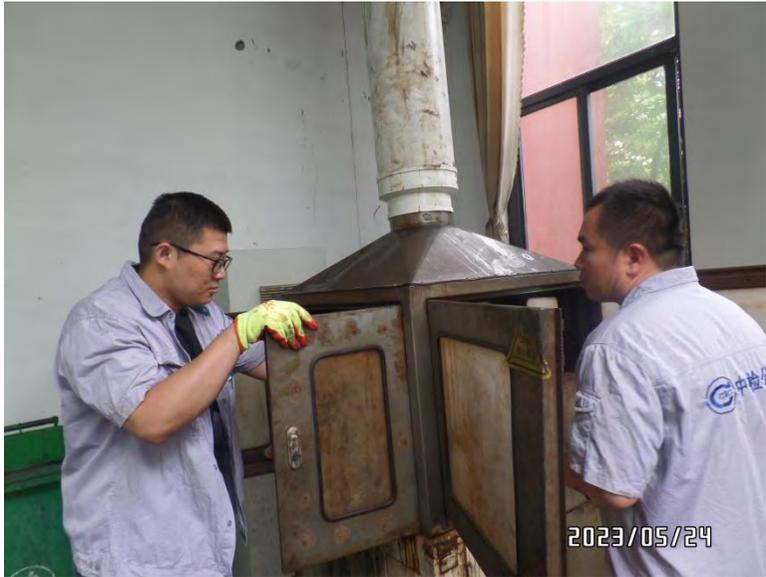
序号	报告编号	发布日期	结论	影像资料
330	GX-B1363/22-A-23230	2023/5/30	所检项目合格。

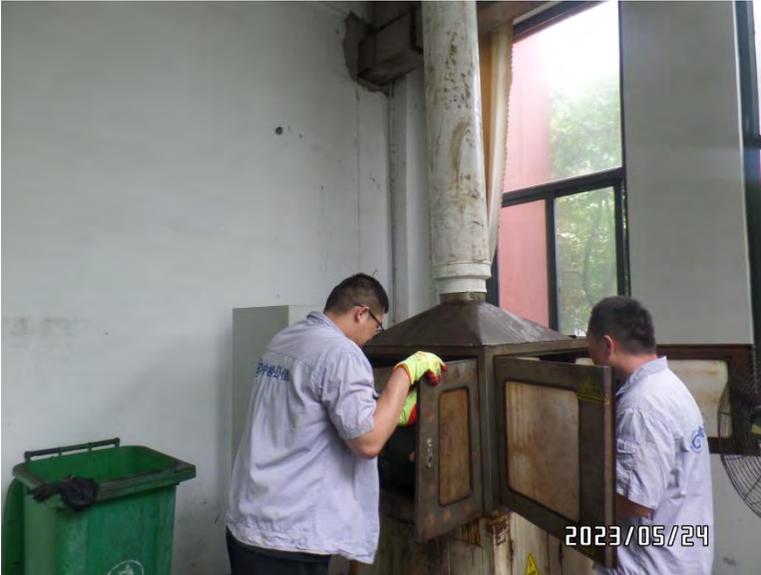
序号	报告编号	发布日期	结论	影像资料
331	GX-B1363/20-A-23232	2023/5/30	所检项目合格。

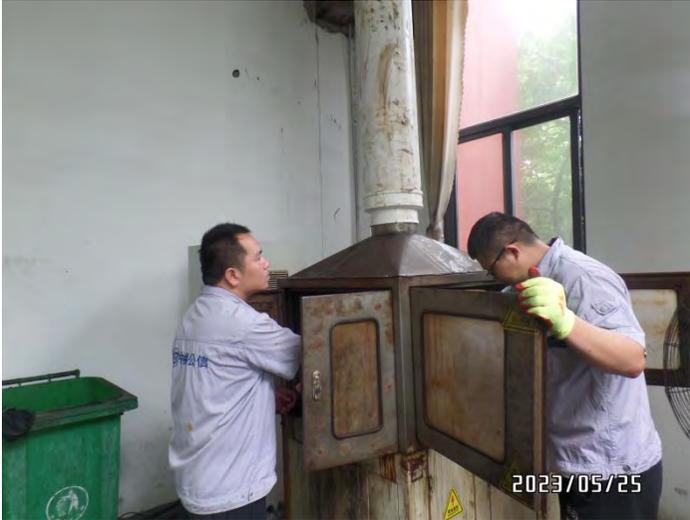
序号	报告编号	发布日期	结论	影像资料
332	GX-B1363/20-A-23233	2023/5/30	所检项目合格。

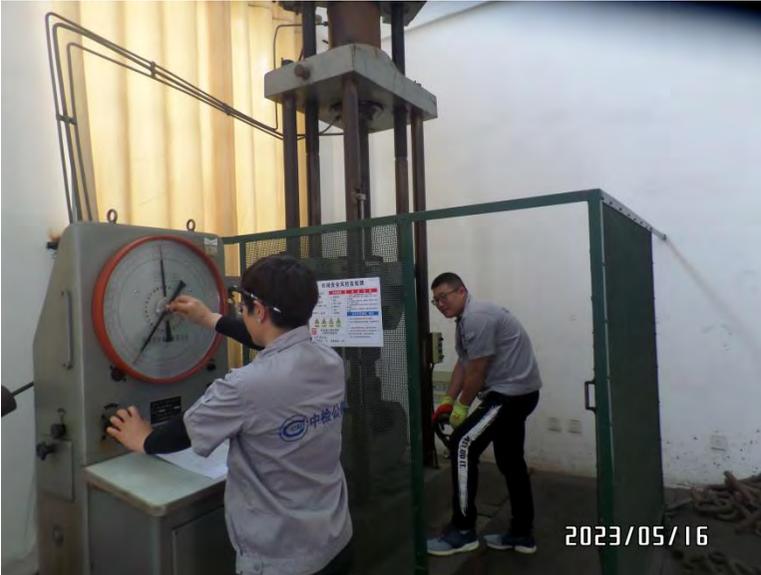
序号	报告编号	发布日期	结论	影像资料
333	GX-B1369/22-A-23002	2023/5/26	所检项目合格。

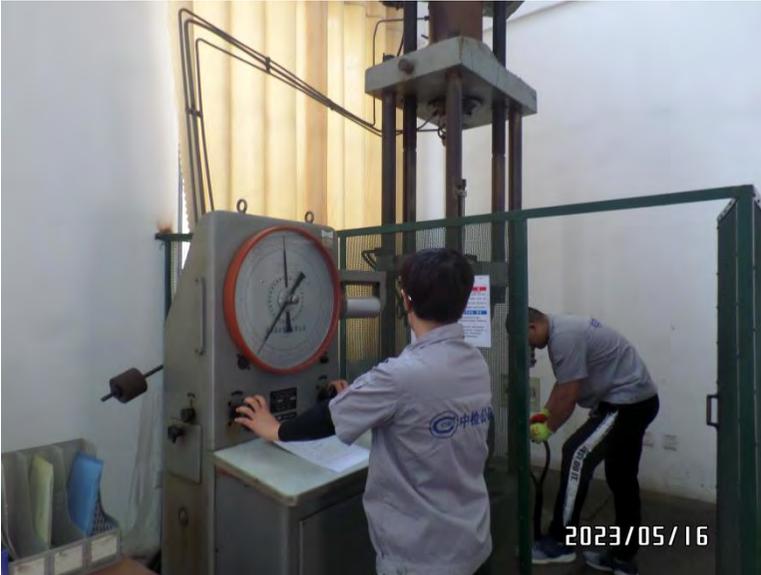
序号	报告编号	发布日期	结论	影像资料
334	GX-B1369/22-A-23003	2023/5/26	所检项目合格。

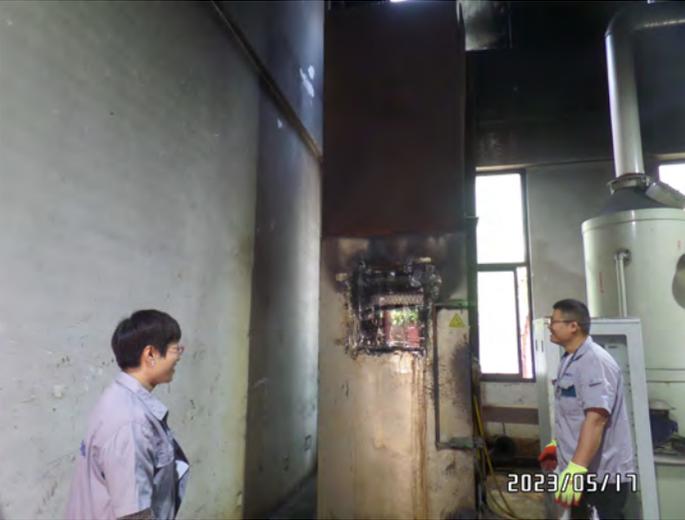
序号	报告编号	发布日期	结论	影像资料
335	GX-B1364/20-A-23401	2023/5/26	成束电线电缆燃烧试验不合格;其余所检项目合格。

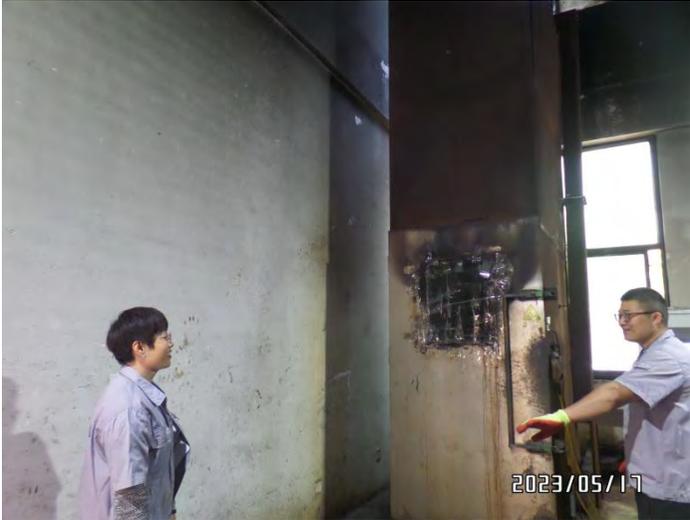
序号	报告编号	发布日期	结论	影像资料
336	GX-B1364/20-A-23400	2023/5/26	所检项目合格。

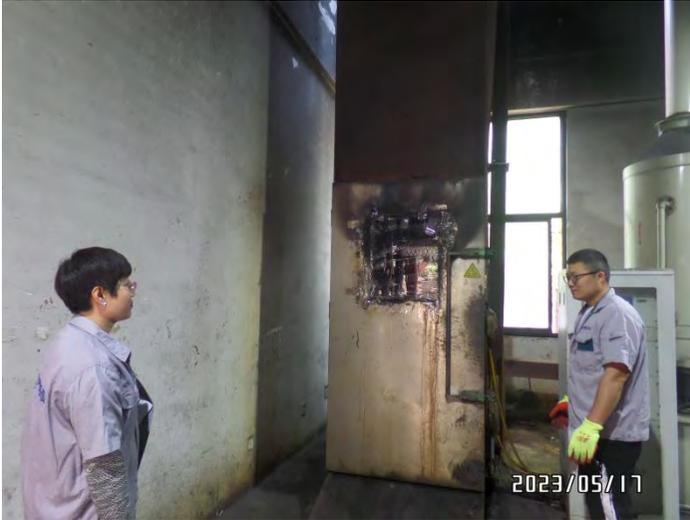
序号	报告编号	发布日期	结论	影像资料
337	GX-B1364/20-A-23399	2023/5/26	所检项目合格。

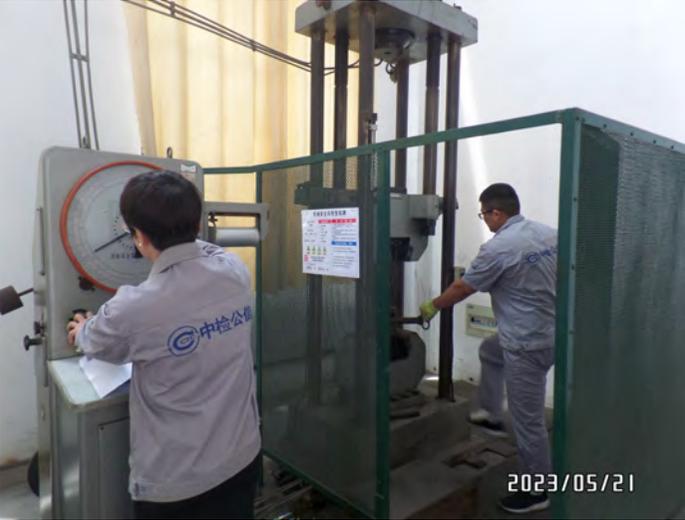
序号	报告编号	发布日期	结论	影像资料
338	GX-B1366/20-A-23052	2023/5/26	所检项目全部合格。

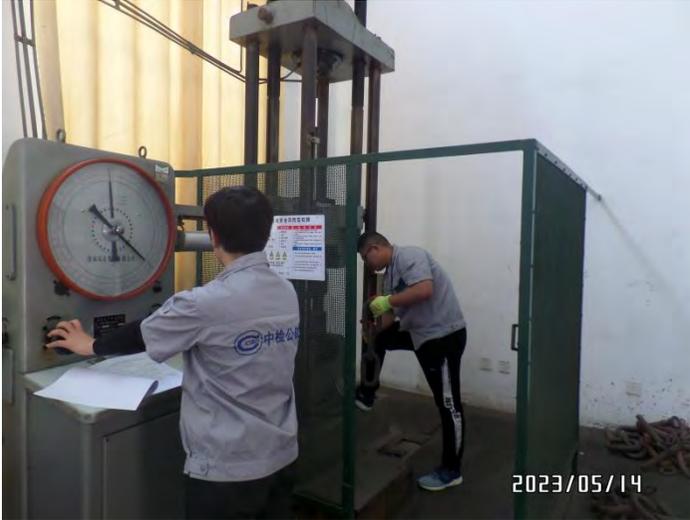
序号	报告编号	发布日期	结论	影像资料
339	GX-B1365/20-A-23036	2023/5/26	所检项目全部合格。

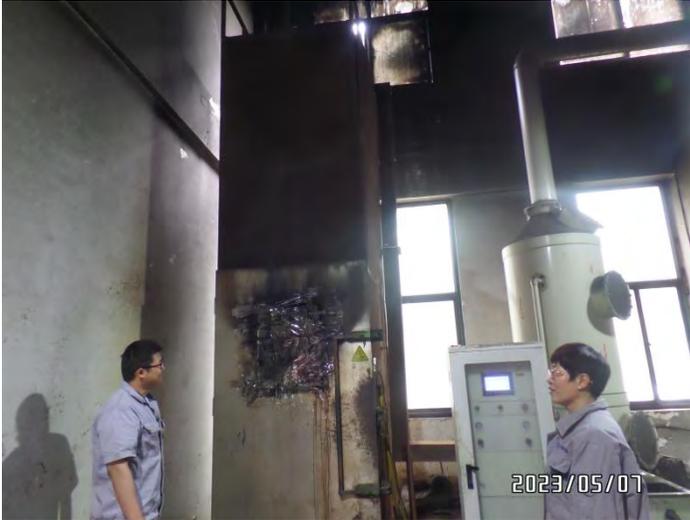
序号	报告编号	发布日期	结论	影像资料
340	GX-B1364/20-A-23362	2023/5/26	所检项目合格。

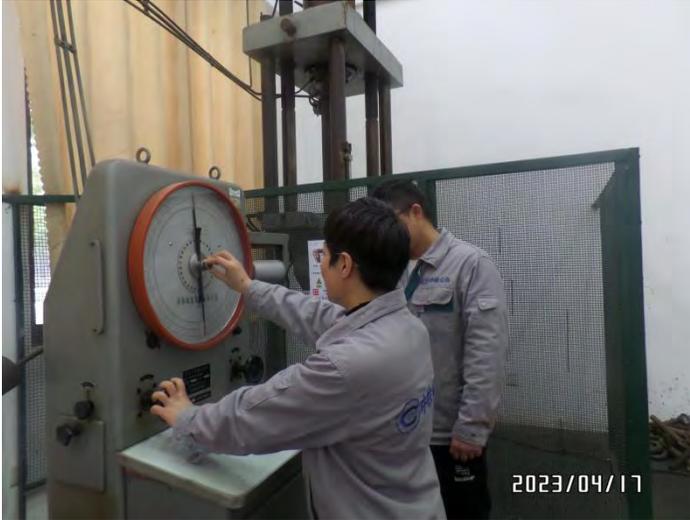
序号	报告编号	发布日期	结论	影像资料
341	GX-B1366/20-A-23031	2023/5/26	所检项目全部合格。

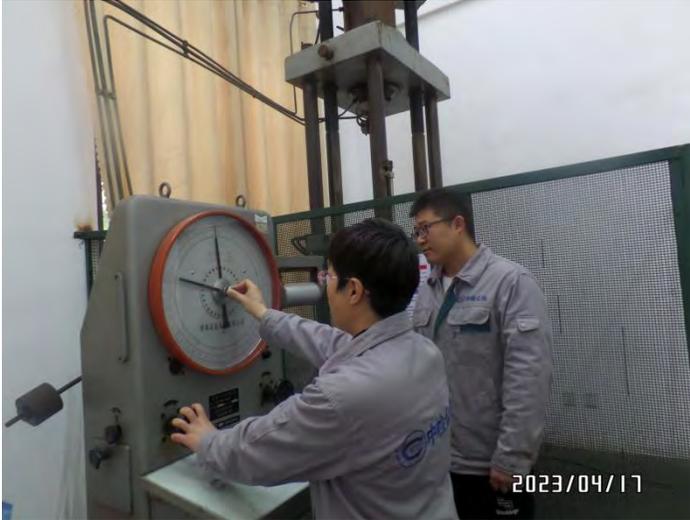
序号	报告编号	发布日期	结论	影像资料
342	GX-B1366/20-A-23030	2023/5/26	所检项目全部合格。

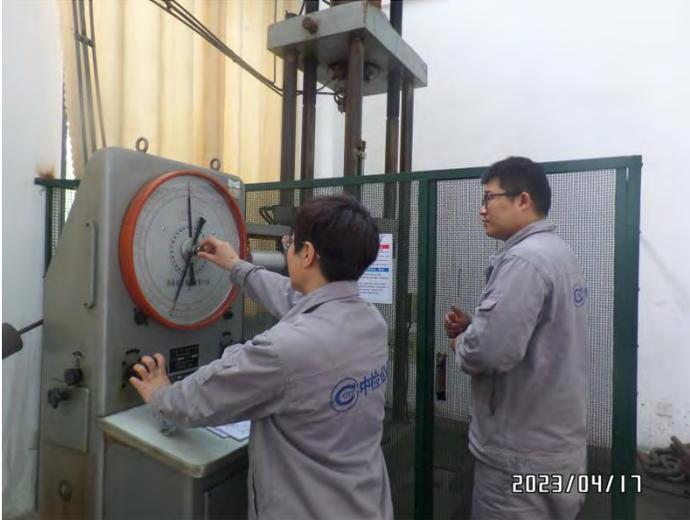
序号	报告编号	发布日期	结论	影像资料
343	GX-B1366/20-A-23033	2023/5/26	所检项目全部合格。

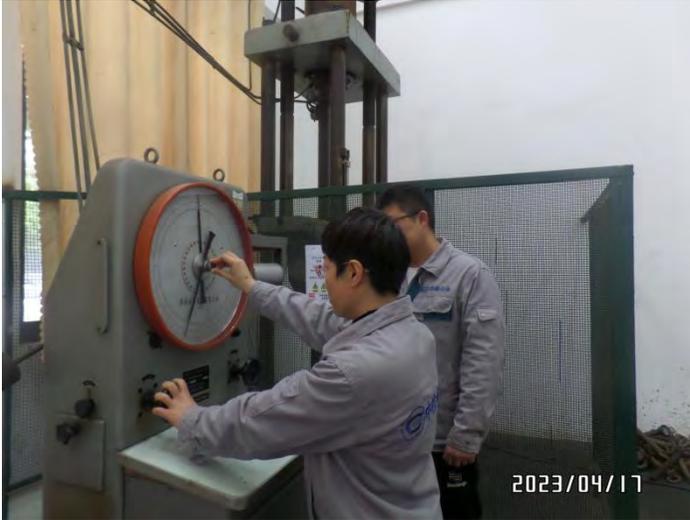
序号	报告编号	发布日期	结论	影像资料
344	GX-B1366/20-A-23032	2023/5/26	所检项目全部合格。

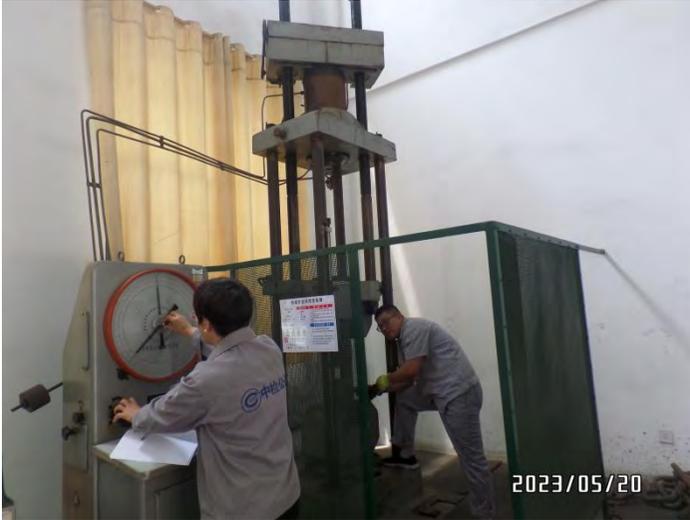
序号	报告编号	发布日期	结论	影像资料
345	GX-B1366/20-A-23051	2023/5/26	所检项目全部合格。

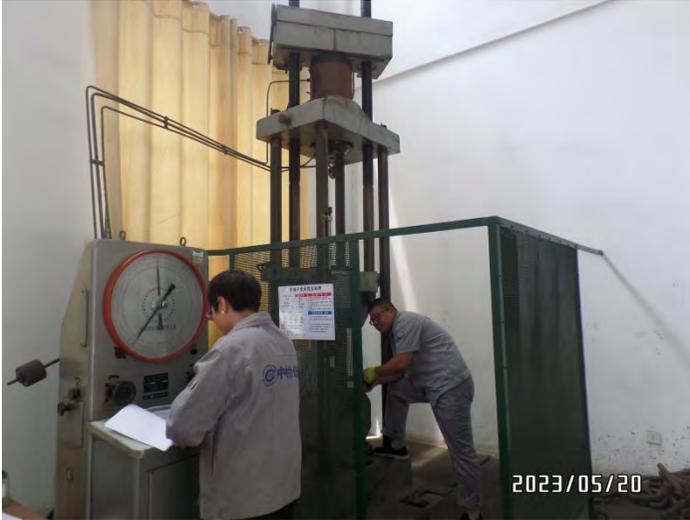
序号	报告编号	发布日期	结论	影像资料
346	GX-B1366/20-A-23050	2023/5/26	所检项目全部合格。

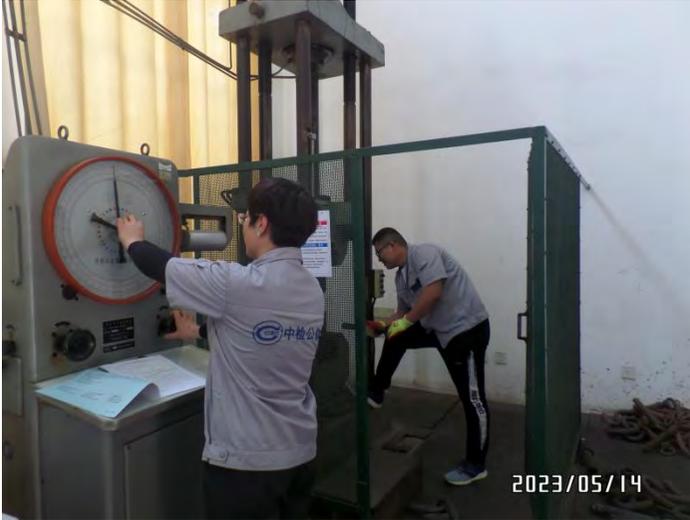
序号	报告编号	发布日期	结论	影像资料
347	GX-B1366/20-A-23049	2023/5/26	所检项目全部合格。

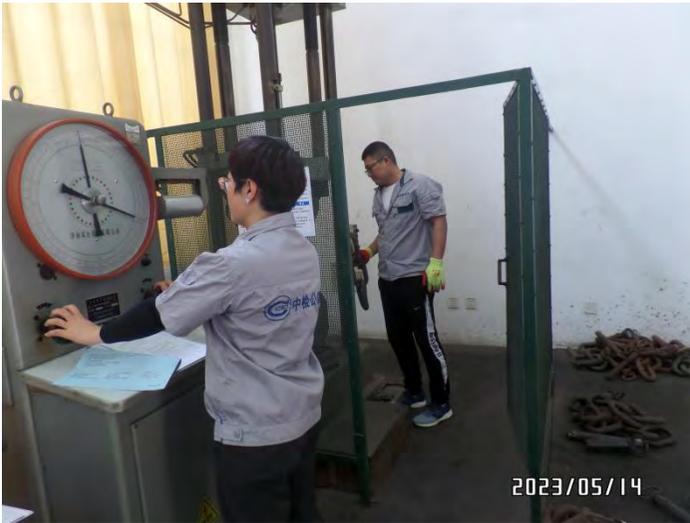
序号	报告编号	发布日期	结论	影像资料
348	GX-B1365/20-A-23037	2023/5/26	所检项目全部合格。

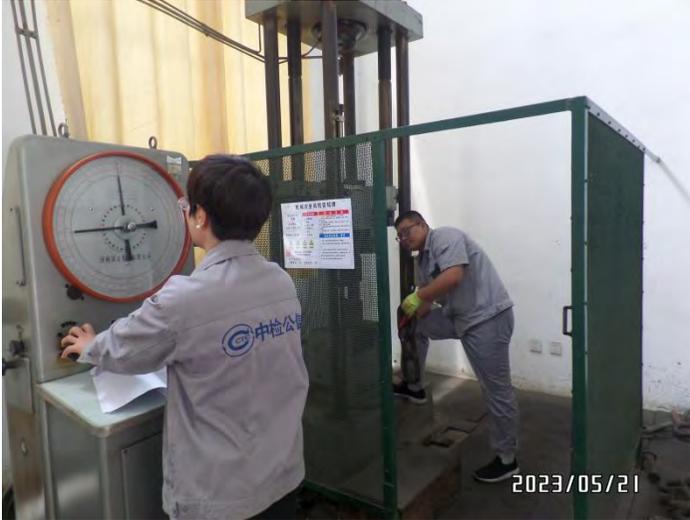
序号	报告编号	发布日期	结论	影像资料
349	GX-B1365/20-A-23038	2023/5/26	所检项目全部合格。
