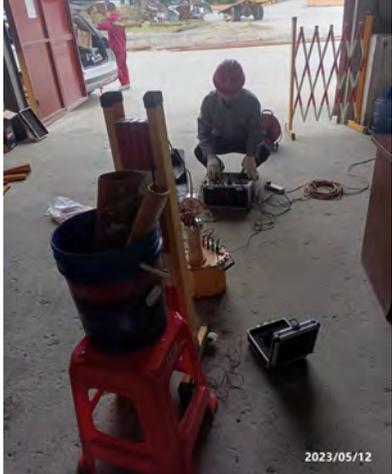
序号	报告编号	发布日期	结论	影像资料
44	GX-B1328/20-2-23080	2023.6.5	本次共检绝缘手套4双，4双所检项目合格。

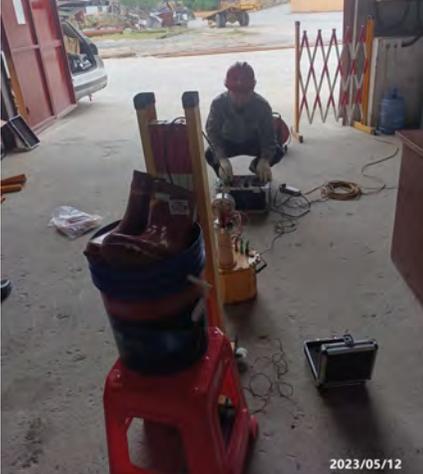
45	GX-B1328/20-2-23081	2023.6.5	本次共检绝缘鞋1双，1双所检项目合格。

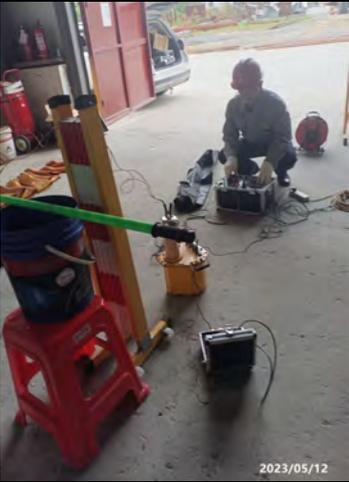
46	GX-B1328/20-2-23082	2023.6.5	本次共检绝缘杆2组，2组所检项目合格。

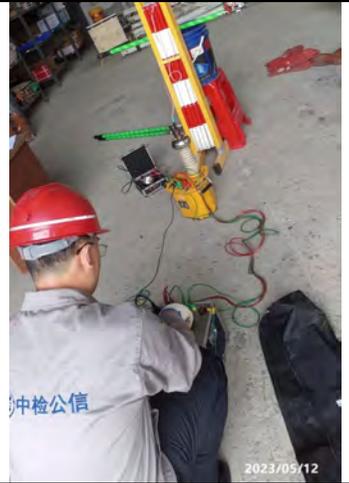
47	GX-B1328/20-2-23083	2023.6.5	本次共检便携式接地和接地短路装置2组，2组所检项目合格。

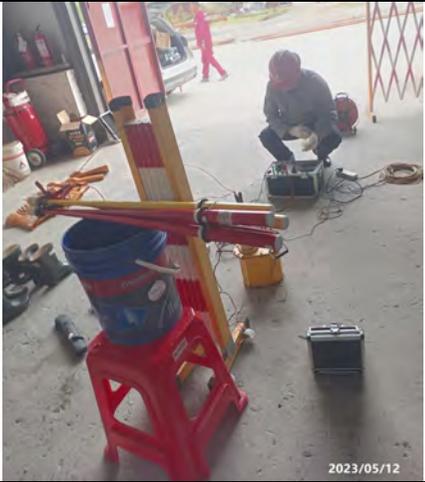
48	GX-B1328/20-2-23084	2023.6.5	本次共检验电器2支，2支所检项目合格。

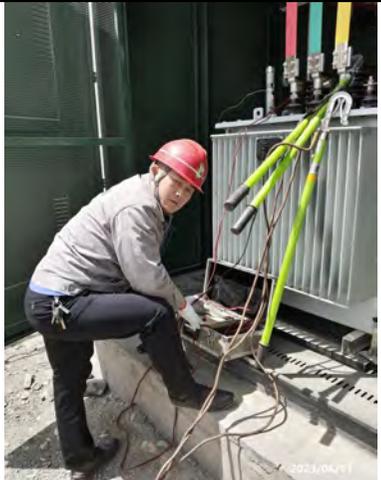
49	GX-B1312/20-2-23122~23123	2023.6.5	本次共检电力变压器2台，2台电力变压器所检项目合格。

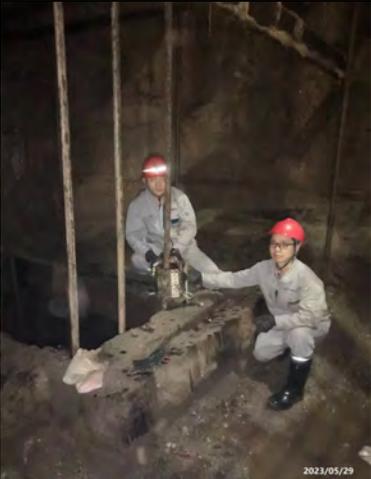
50	GX-B1598/21-2-23037	2023. 6. 5	实测钢丝绳有效截面积损失百分比最大为1.51%，小于5%为正常。

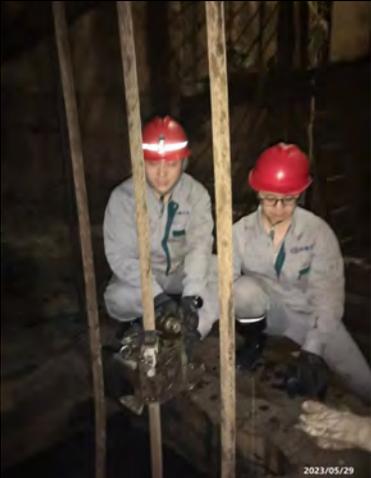
A photograph showing two workers in a dark tunnel environment. They are wearing red hard hats and light-colored work clothes. One worker is kneeling and pointing towards a steel cable that is part of a larger piece of equipment or structure. The other worker is standing nearby. The date '2023/05/29' is visible in the bottom right corner of the photo.
51	GX-B1598/21-2-23038	2023. 6. 5	实测钢丝绳有效截面积损失百分比最大为0.86%，小于5%为正常。

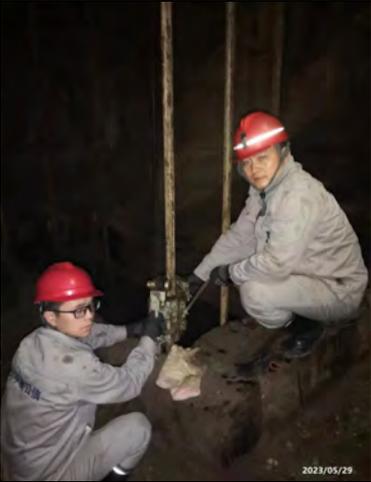
52	GX-B1598/21-2-23039	2023. 6. 5	实测钢丝绳有效截面积损失百分比最大为0.99%，小于5%为正常。

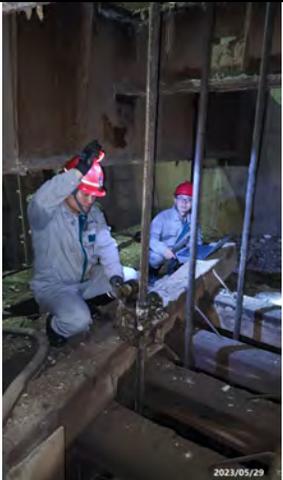
<p>2023/05/29</p>
53	GX-B1598/21-2-23040	2023. 6. 5	实测钢丝绳有效截面积损失百分比最大为1.51%，小于5%为正常。

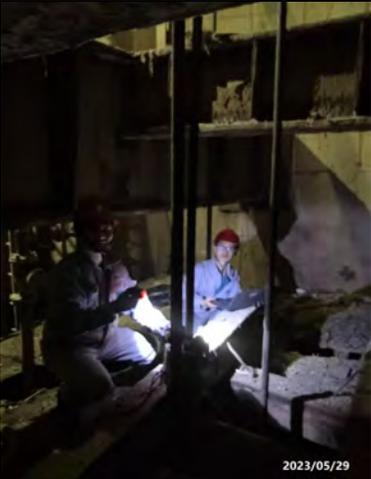
54	GX-B1598/21-2-23041	2023.6.5	实测钢丝绳有效截面积损失百分比最大为0.78%，小于5%为正常。

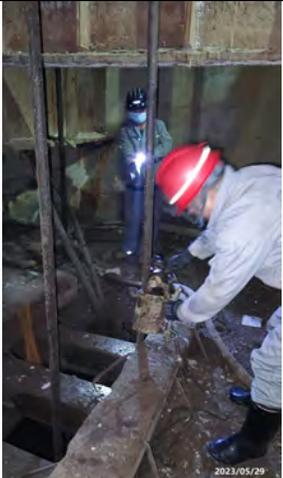
<p>2023/05/29</p>
55	GX-B1598/21-2-23042	2023.6.5	实测钢丝绳有效截面积损失百分比最大为0.63%，小于5%为正常。

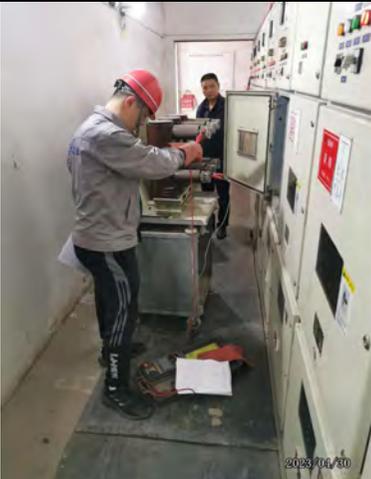
56	GX-B1495/20-2-23382~23392	2023. 6. 5	所检项目合格

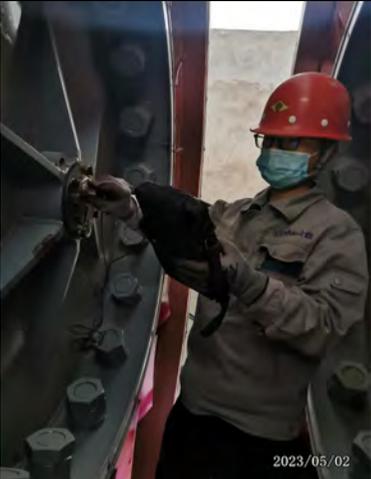
57	GX-B1310/21-2-23101	2023. 6. 5	未发现超过 $\Phi 2\text{mm}$ 当量直径的缺陷。

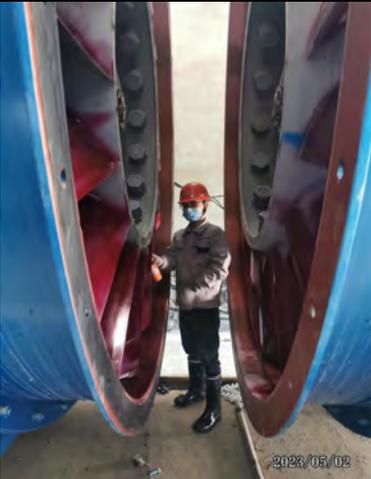
58	GX-B1428/21-2-23101	2023. 6. 5	无缺陷迹痕显示。

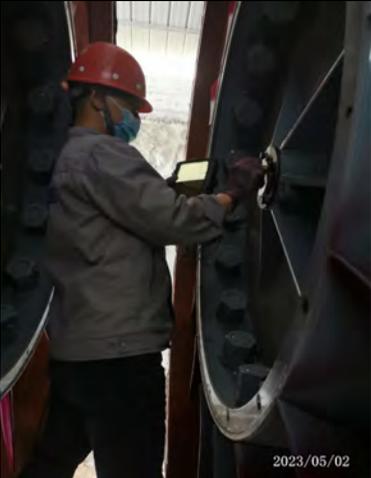
59	GX-B1310/21-2-23102	2023. 6. 5	未发现超过 $\Phi 2\text{mm}$ 当量直径的缺陷。

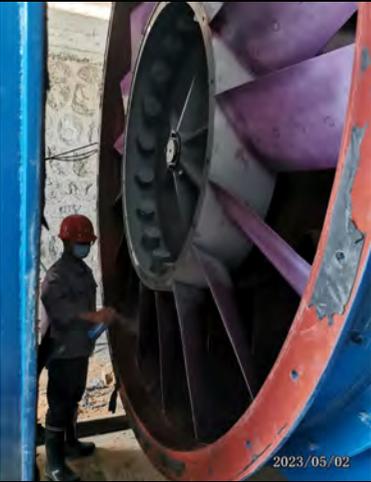
60	GX-B1428/21-2-23102	2023.6.5	无缺陷迹痕显示。

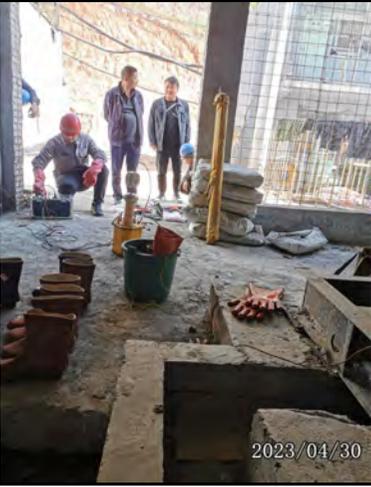
61	GX-B1328/20-2-23085	2023.6.5	本次共检绝缘手套4副，4副所检项目合格。

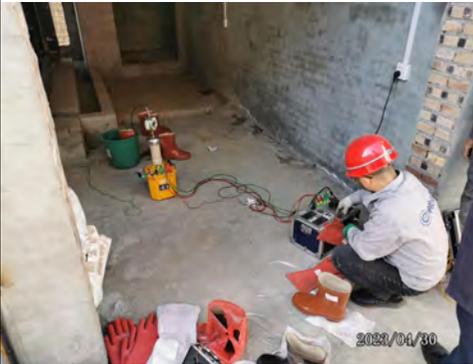
62	GX-B1328/20-2-23086	2023.6.5	本次共检绝缘鞋4双，4双所检项目合格。

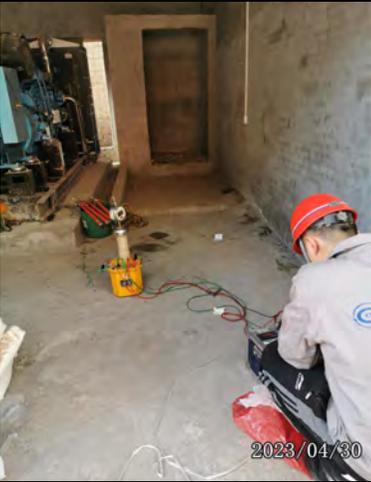
64	GX-B1328/20-2-23088	2023.6.5	本次共检便携式接地和接地短路装置2组，2组所检项目合格。

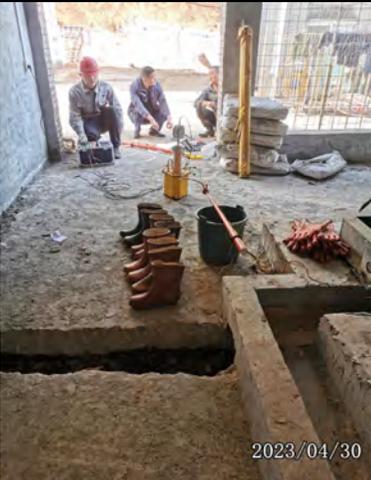
65	GX-B1328/20-2-23089	2023.6.5	本次共检验电器4支，4支所检项目合格。

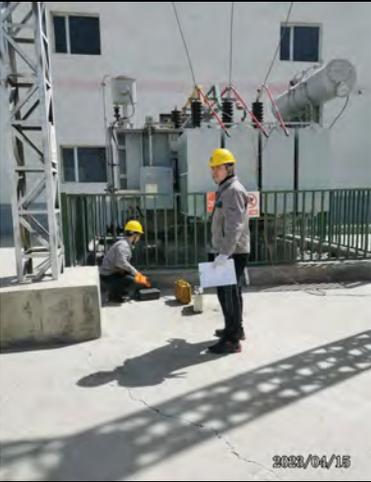
66	GX-B1312/20-2-23152~23153	2023.6.5	本次共检电力变压器2台，2台所检项目合格。

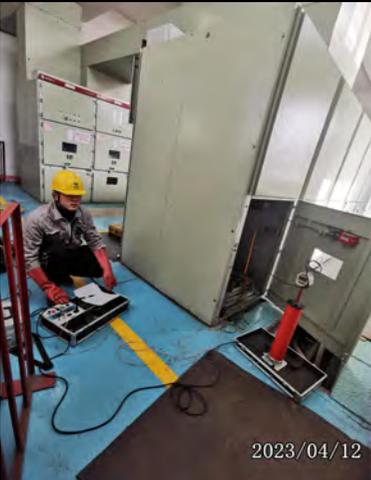
67	GX-B1321/20-2-23170~23184	2023.6.5	本次共检电力电缆15条，15条电力电缆所检项目合格。

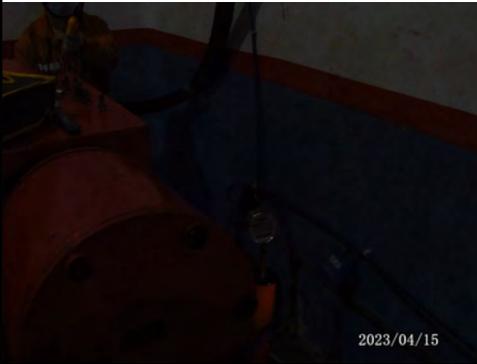
68	GX-B1321/20-2-23196~23205	2023.6.5	本次共检电力电缆10条，10条电力电缆所检项目合格。

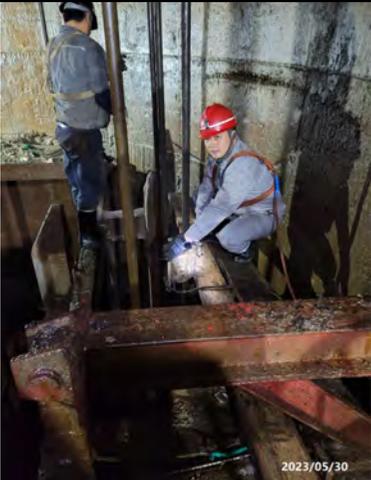
69	GX-B1598/21-2-23043	2023.6.5	实测钢丝绳有效截面积损失百分比最大为4.09%，小于5%为正常。

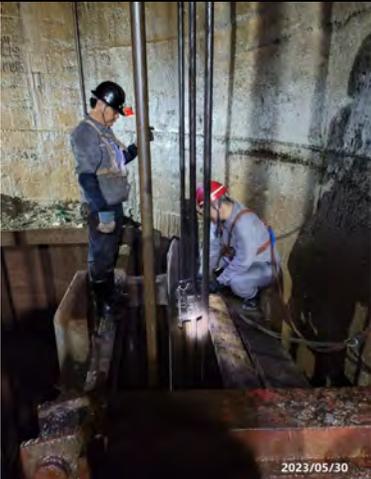
70	GX-B1598/21-2-23044	2023.6.5	实测钢丝绳有效截面积损失百分比最大为4.36%，小于5%为正常。

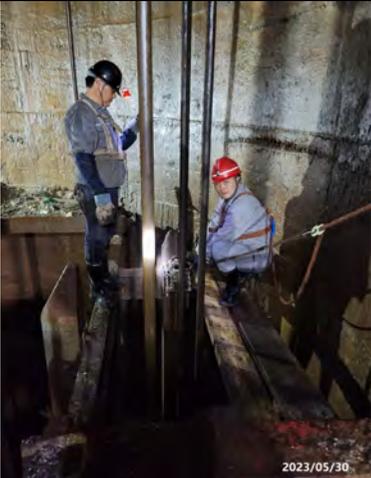
71	GX-B1598/21-2-23045	2023.6.5	实测钢丝绳有效截面积损失百分比最大为2.81%，小于5%为正常。

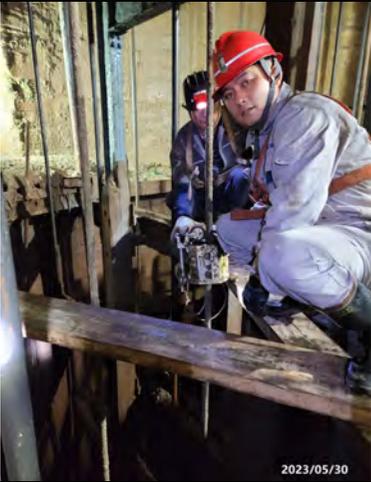
72	GX-B1598/21-2-23046	2023. 6. 5	实测钢丝绳有效截面积损失百分比最大为1.63%，小于5%为正常。

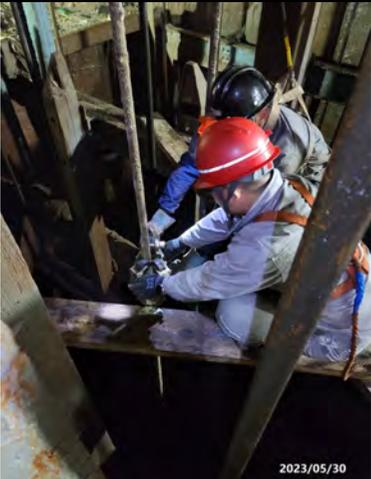
<p>2023/05/30</p>
73	GX-B1598/21-2-23047	2023. 6. 5	实测钢丝绳有效截面积损失百分比最大为1.70%，小于5%为正常。

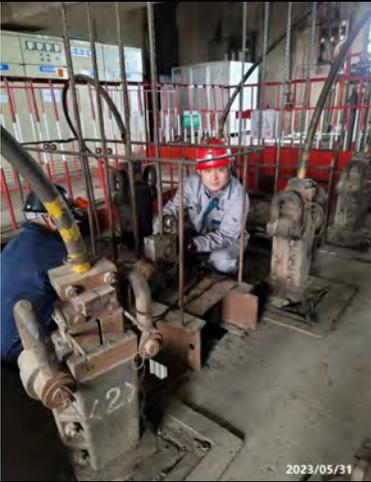
74	GX-B1598/21-2-23048	2023.6.5	实测钢丝绳有效截面积损失百分比最大为2.71%，小于5%为正常。

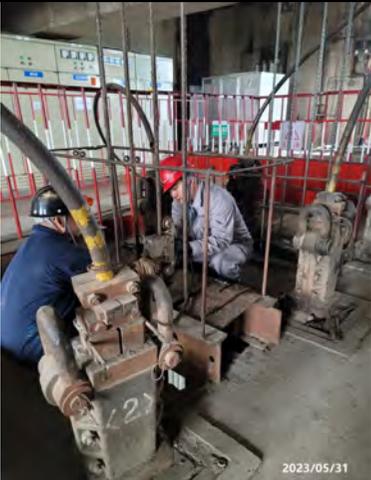
75	GX-B1598/21-2-23049	2023.6.5	实测钢丝绳有效截面积损失百分比最大为2.45%，小于5%为正常。

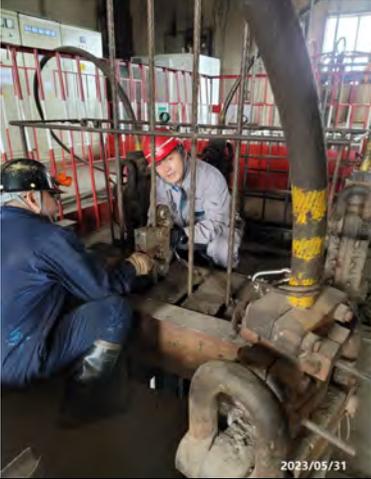
76	GX-B1598/21-2-23050	2023.6.5	实测钢丝绳有效截面积损失百分比最大为3.43%，小于5%为正常。

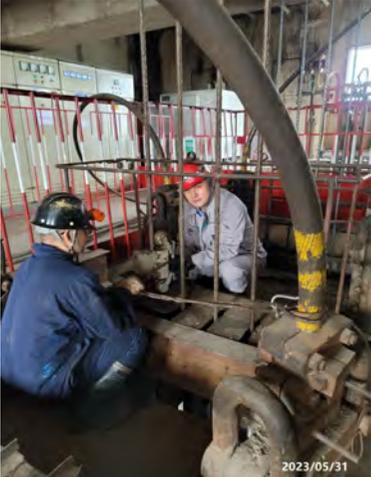
77	GX-B1598/21-2-23051	2023.6.5	实测钢丝绳有效截面积损失百分比最大为1.50%，小于5%为正常。

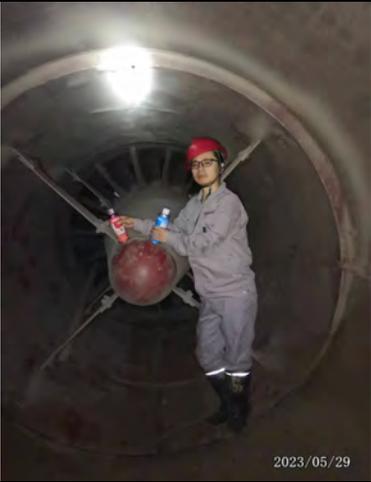
78	GX-B1428/21-2-23112	2023.6.5	无缺陷迹痕显示

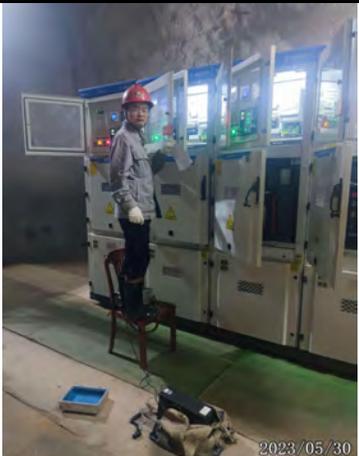
<p>2023/04/11</p>
101	GX-B1451/20-2-23239~23251	2023/6/6	本次共检高压开关柜13台，13台所检项目合格。

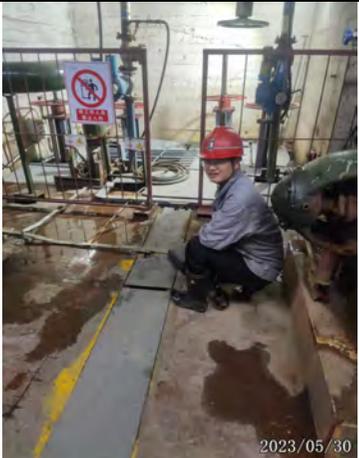
102	GX-B1350/21-2-23022	2023/6/6	本次共检验接地装置4处，4处所检项目合格。

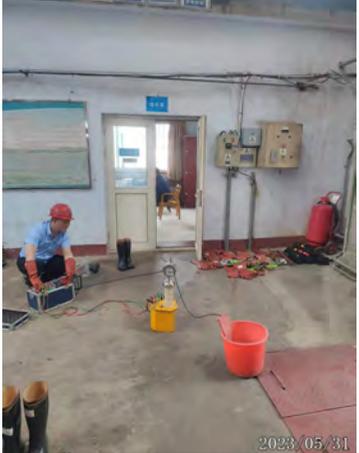
103	GX-B1328/20-2-23090	2023/6/7	本次共检绝缘手套38双，38双所检项目合格。

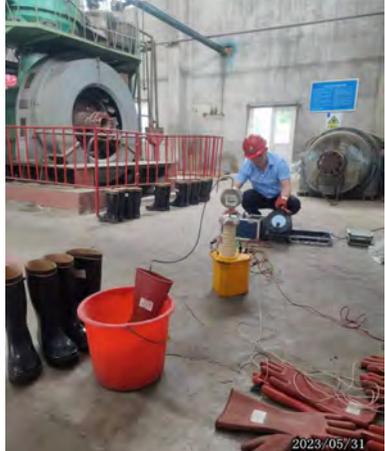
105	GX-B1328/20-2-23092	2023/6/7	本次共检绝缘手套50双，50双所检项目合格。

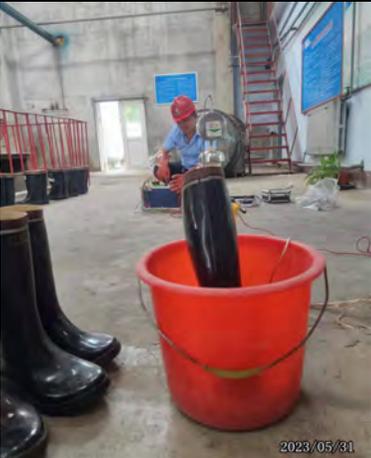
106	GX-B1328/20-2-23093	2023/6/7	本次共检绝缘鞋35双，35双所检项目合格。

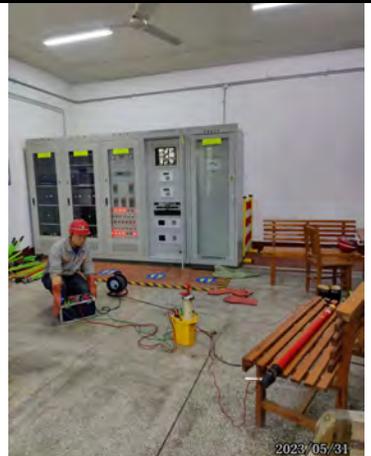
107	GX-B1328/20-2-23094	2023/6/7	本次共检验电器16支，16支所检项目合格。

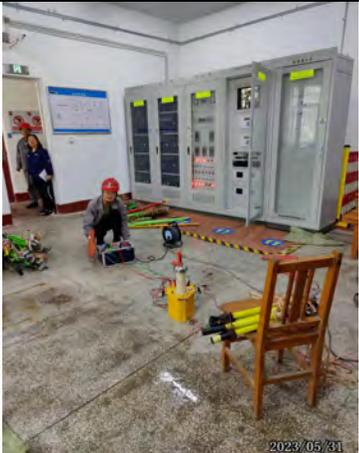
108	GX-B1328/20-2-23095	2023/6/7	本次共检便携式接地和接地短路装置58组，58组所检项目合格。

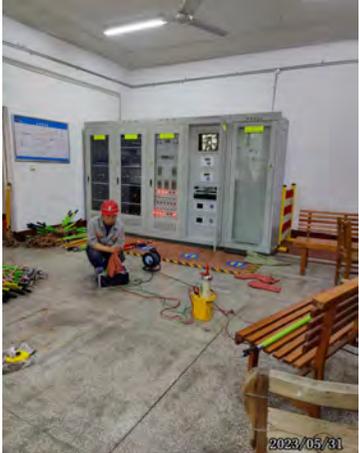
<p>2023/05/31</p>
109	GX-B1328/20-2-23096	2023/6/7	本次共检绝缘杆19组，19组所检项目合格。

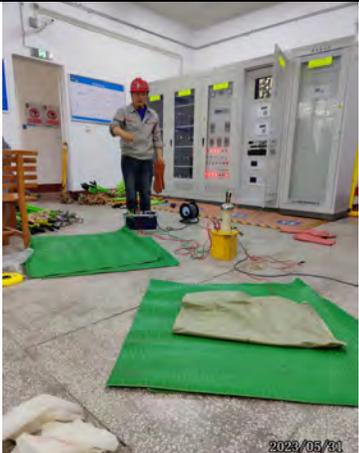
110	GX-B1328/20-2-23097	2023/6/7	本次共检绝缘胶垫7块，7块所检项目合格。

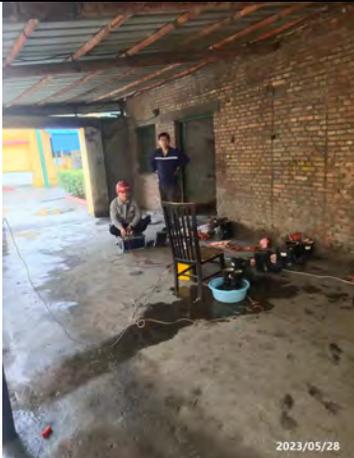
112	GX-B1328/20-2-23099	2023/6/7	本次共检绝缘鞋52双，52双所检项目合格。

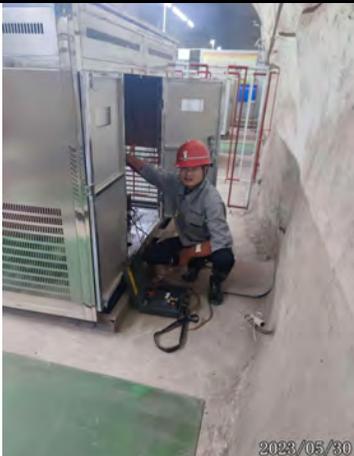
113	GX-B1313/21-2-23115~23116	2023/6/7	本次共检电力变压器2台，2台所检项目合格。

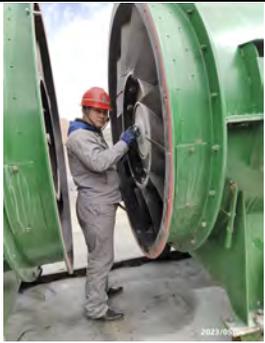
114	GX-B1310/21-2- 23103	2023. 6. 9	未发现超过 $\Phi 2\text{mm}$ 当量直径的缺陷。

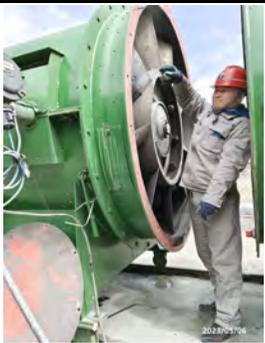
115	GX-B1428/21-2- 23103	2023. 6. 9	无缺陷迹痕显示。
