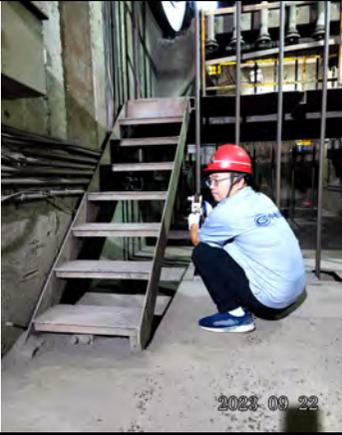
序号	报告编号	发布日期	结论	影像资料
136	GX-B1598/21-6-23043	2023/10/13	实测钢丝绳有效截面积损失百分比最大为0.88%，小于5%为正常。

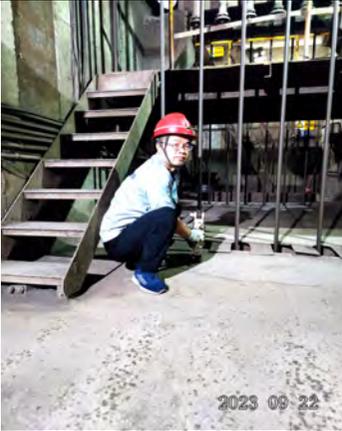
137	GX-B1598/21-6-23044	2023/10/13	实测钢丝绳有效截面积损失百分比最大为1.15%，小于5%为正常。

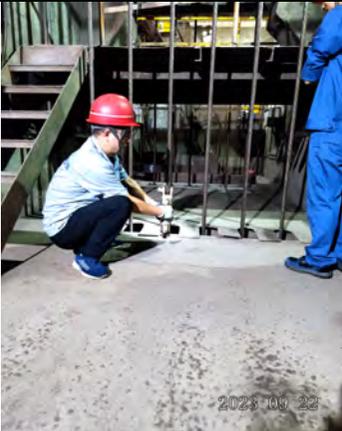
138	GX-B1598/21-6-23045	2023/10/13	实测钢丝绳有效截面积损失百分比最大为1.65%，小于5%为正常。

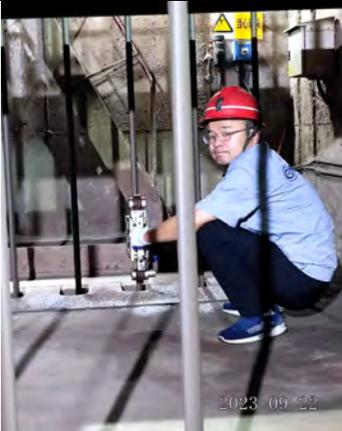
139	GX-B1598/21-6-23046	2023/10/13	实测钢丝绳有效截面积损失百分比最大为1.56%，小于5%为正常。

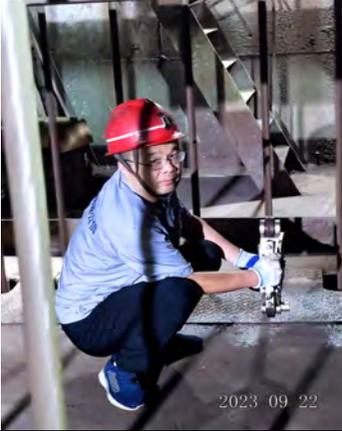
140	GX-B1598/21-6-23047	2023/10/13	实测钢丝绳有效截面积损失百分比最大为0.92%，小于5%为正常。

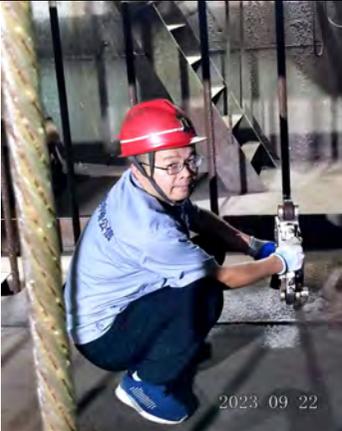
141	GX-B1598/21-6-23048	2023/10/13	实测钢丝绳有效截面积损失百分比最大为1.26%，小于5%为正常。

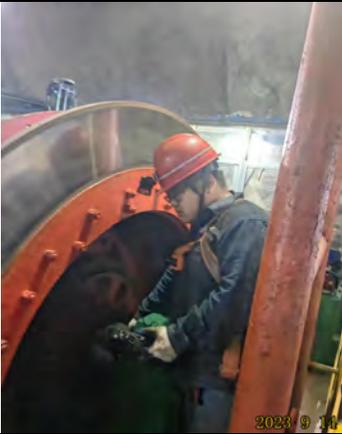
148	GX-B1310/21-6-23134	2023/10/13	符合标准要求

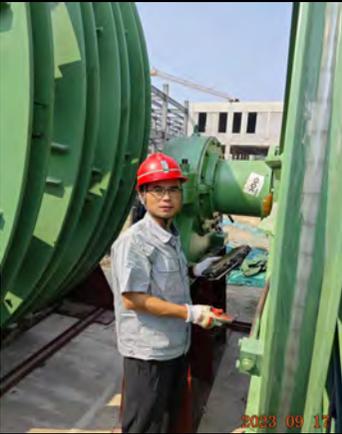
149	GX-B1310/21-6-23141	2023/10/16	符合标准要求

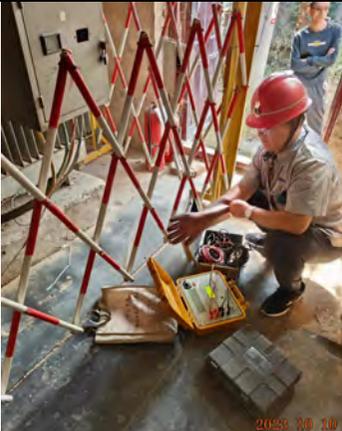
150	GX-B1313/21-6-23234	2023/10/16	所检项目合格

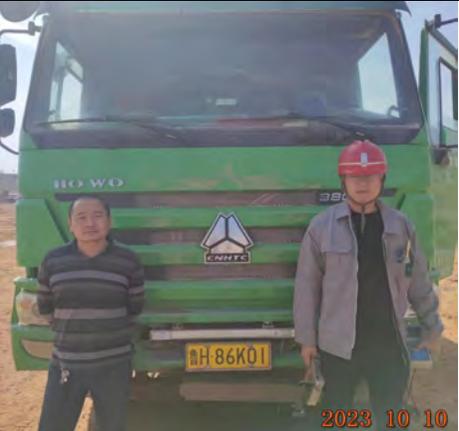
151	GX-B1423/20-6-231026	2023/10/16	综合判定合格

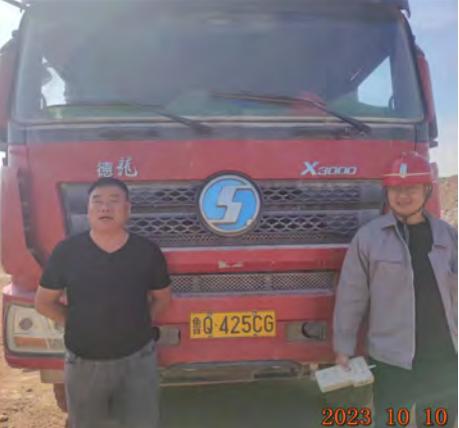
152	GX-B1423/20-6-231027	2023/10/16	综合判定合格

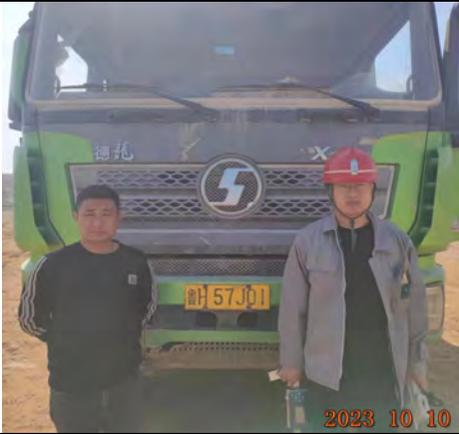
153	GX-B1423/20-6-231028	2023/10/16	综合判定合格

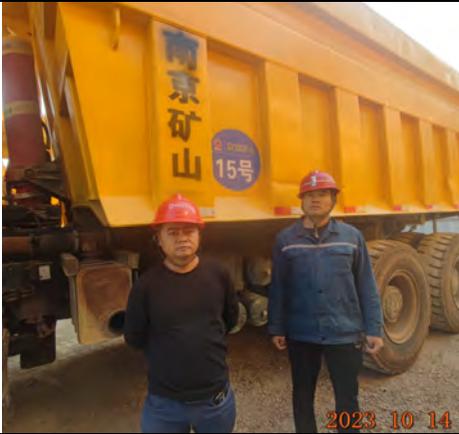
154	GX-B1423/20-6-231029	2023/10/17	综合判定合格

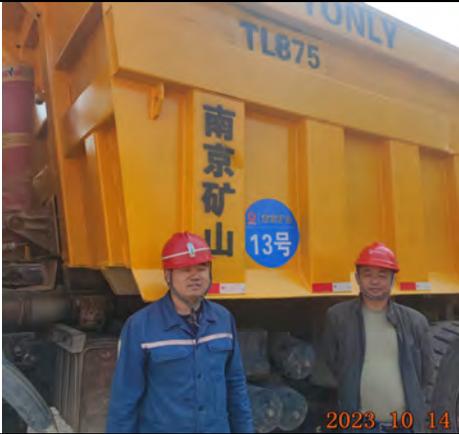
155	GX-B1423/20-6-231030	2023/10/17	综合判定合格

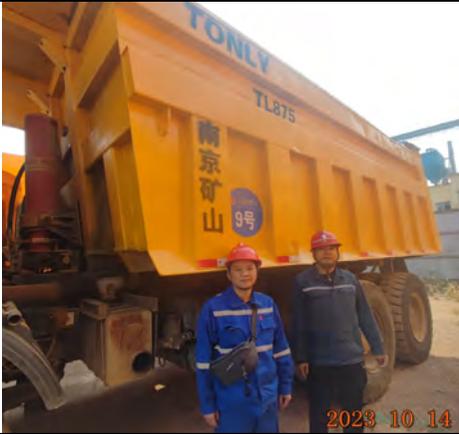
156	GX-B1423/20-6-231031	2023/10/17	综合判定合格

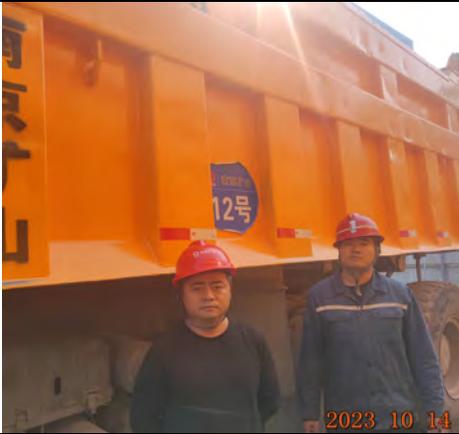
157	GX-B1423/20-6-231032	2023/10/17	综合判定合格

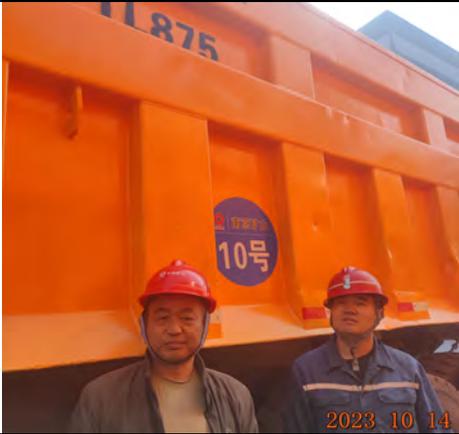
158	GX-B1423/20-6-231033	2023/10/17	综合判定合格

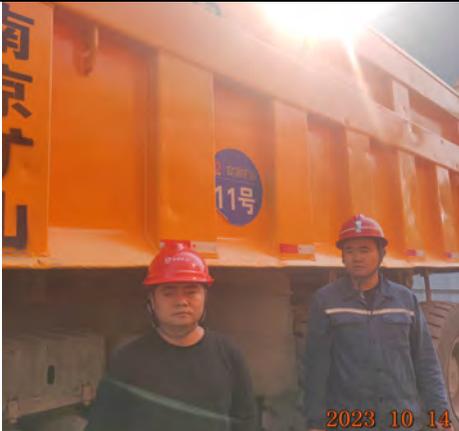
159	GX-B1423/20-6-231034	2023/10/17	综合判定合格

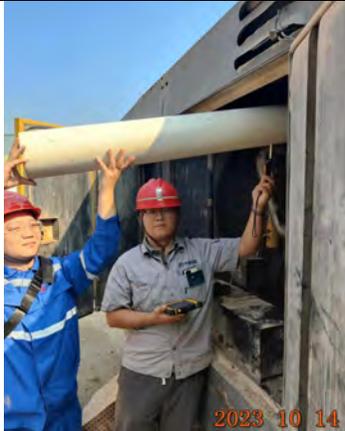
<p>2023 10 14</p>
160	GX-B1520/20-6-23101	2023/10/17	综合判定合格

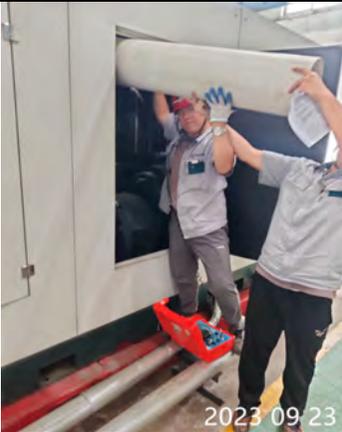
162	GX-B1306/21-6-23016	2023/10/17	所检项目合格

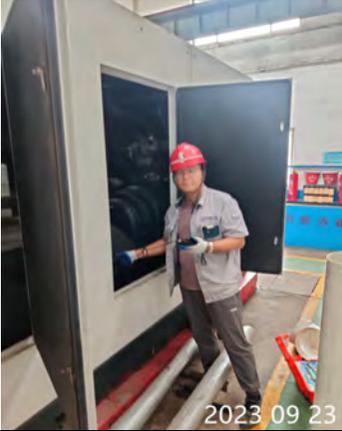
163	GX-B1306/21-6-23017	2023/10/17	所检项目合格

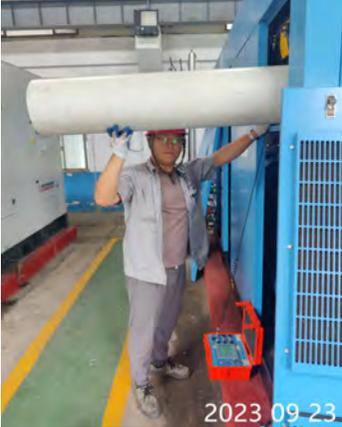
164	GX-B1306/21-6-23018	2023/10/17	所检项目合格

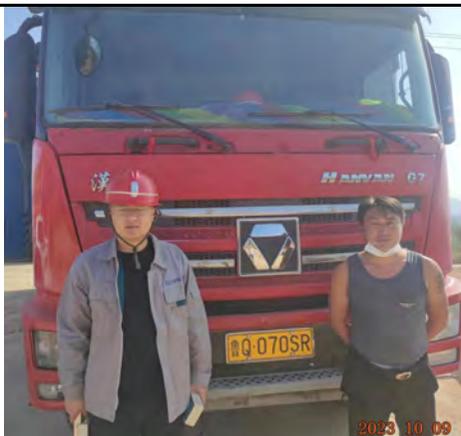
165	GX-B1423/20-6-231020	2023/10/18	综合判定合格

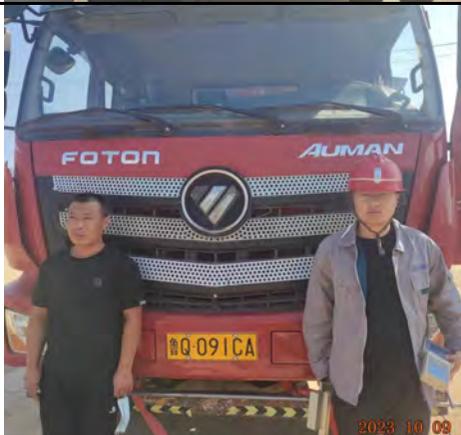
166	GX-B1423/20-6-231021	2023/10/18	综合判定合格

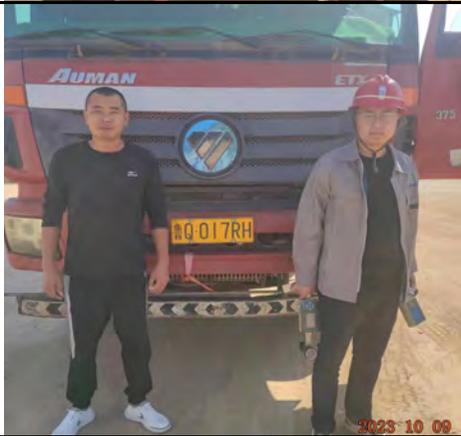
167	GX-B1423/20-6-231022	2023/10/18	综合判定合格

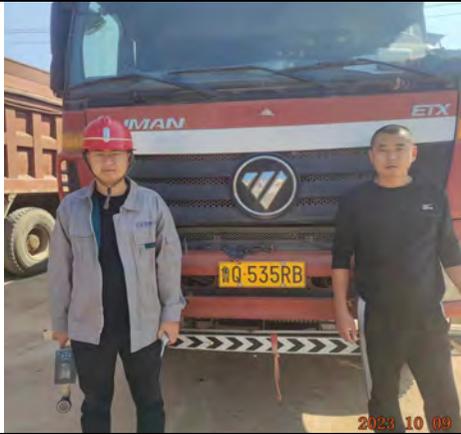
168	GX-B1423/20-6-231023	2023/10/18	综合判定合格

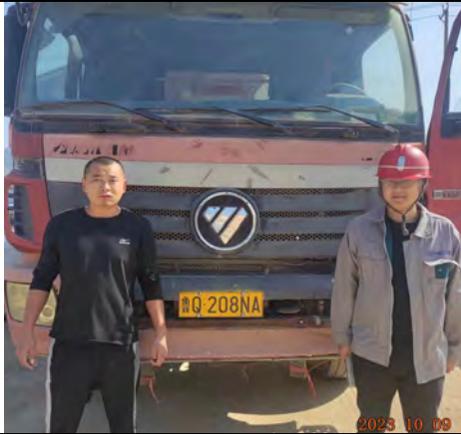
169	GX-B1423/20-6-231024	2023/10/18	综合判定合格

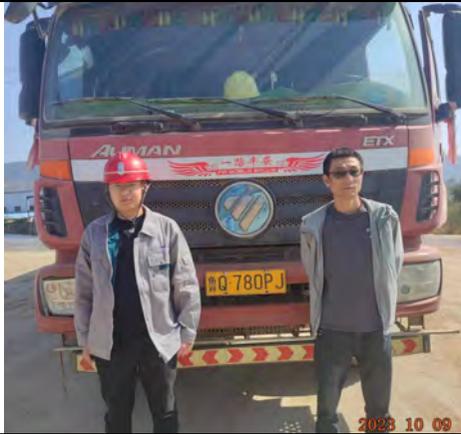
170	GX-B1423/20-6-231025	2023/10/18	综合判定合格

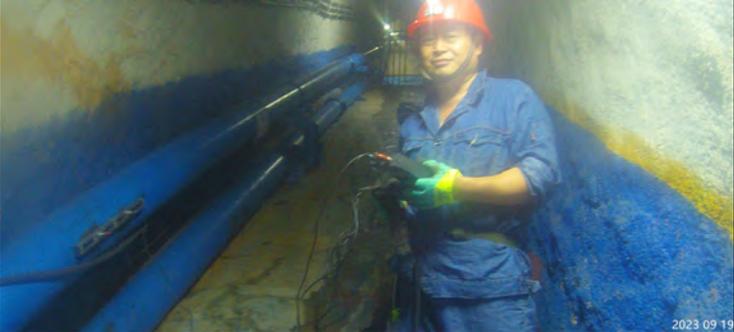
171	GX-B1499/21-6-23036	2023/10/18	所检项目合格

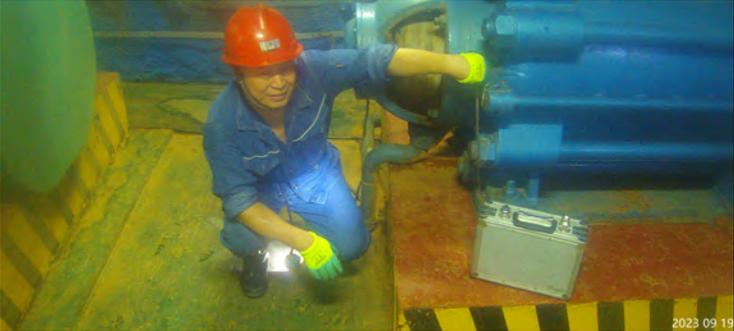
A worker in a blue uniform and red helmet is working on a blue pipe in a tunnel. The worker is holding a tool and looking towards the camera. The date stamp in the bottom right corner of the image is 2023 09 19.
172	GX-B1499/21-6-23037	2023/10/18	所检项目合格

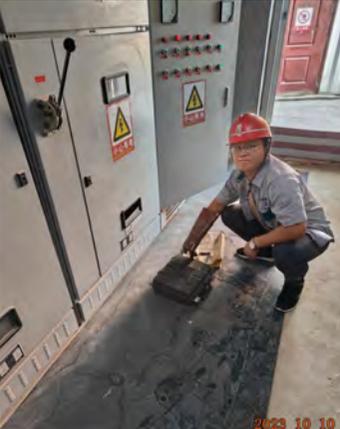
A worker in a blue uniform and red helmet is kneeling and working on a blue pipe. The worker is holding a tool and looking towards the camera. The date stamp in the bottom right corner of the image is 2023 09 19.
173	GX-B1451/20-6-23680~23681	2023/10/13	所检项目合格

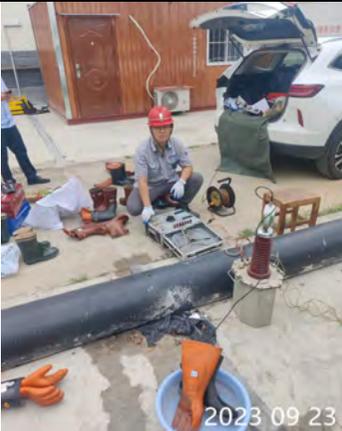
174	GX-B1328/20-6-23130	2023/10/18	所检项目合格

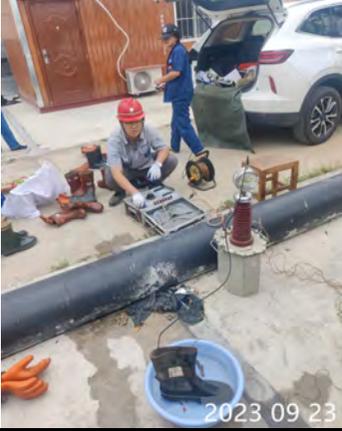
175	GX-B1328/20-6-23131	2023/10/18	所检项目合格

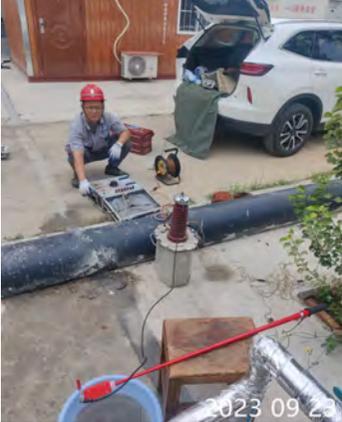
176	GX-B1328/20-6-23132	2023/10/18	所检项目合格

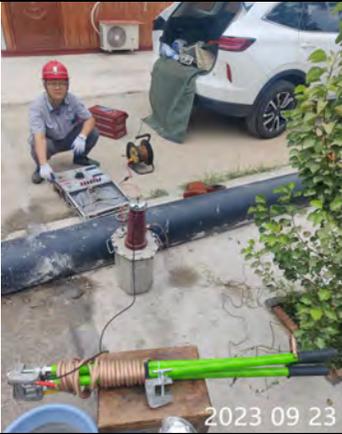
177	GX-B1328/20-6-23133	2023/10/18	所检项目合格

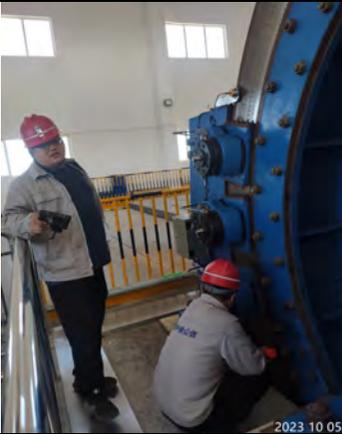
178	GX-B1304/21-6-23028	2023/10/18	综合判定合格

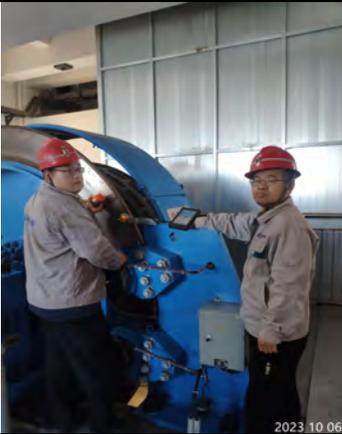
179	GX-B1304/21-6-23029	2023/10/18	综合判定合格

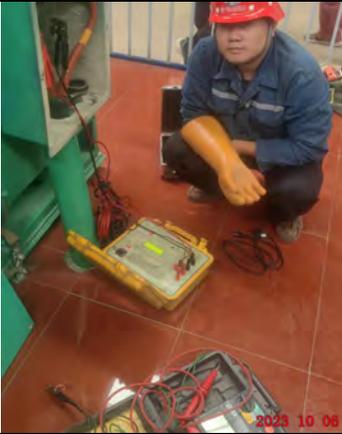
180	GX-B1324/21-6-23047	2023.10.18	所检项目合格

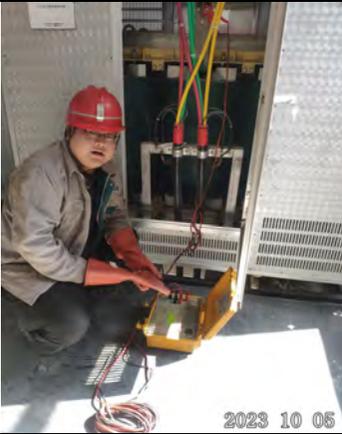
181	GX-B1313/21-6-23242~23245	2023/10/18	所检项目合格

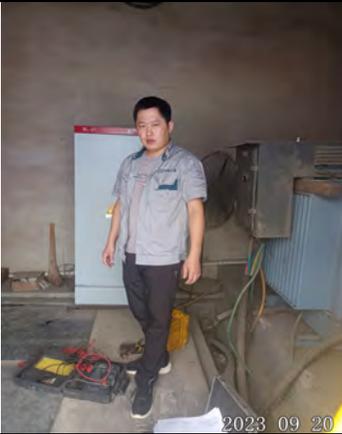
182	GX-B1313/21-6-23235~23240	2023/10/18	所检项目合格

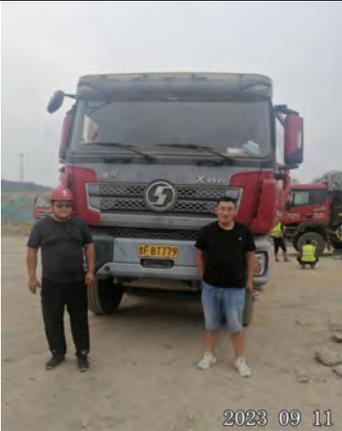
183	GX-B1423/20-6-231002	2023/10/20	综合判定合格

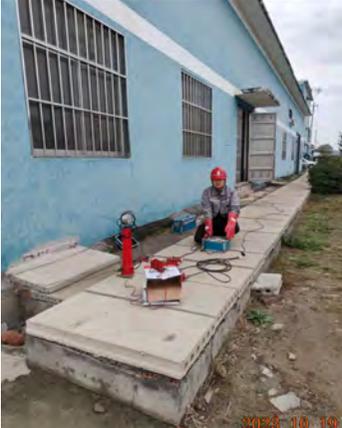
188	GX-B1329/21-6-23109~23110	2023/10/20	<p>本次共检氧化锌避雷器2组，2组氧化锌避雷器所检项目合格。</p>
