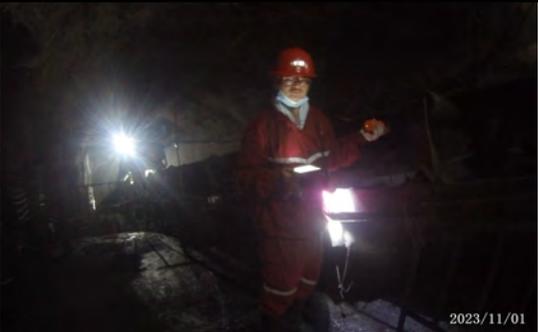
序号	报告编号	发布日期	结论	影像资料
65	GX-B1416/22-2-23068	2023. 11. 14	综合判定：合格。

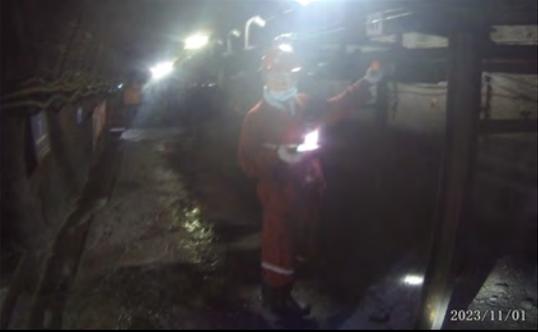
<p>2023/11/01</p>
66	GX-B1416/22-2-23069	2023. 11. 14	综合判定：合格。

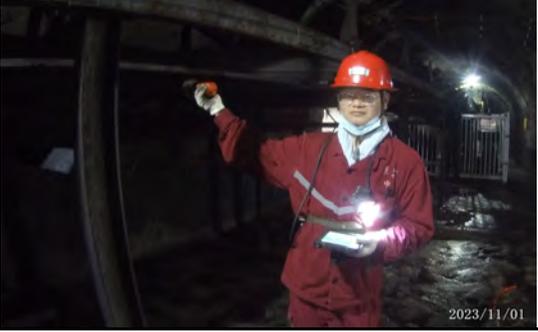
<p>2023/11/01</p>
67	GX-B1416/22-2-23070	2023. 11. 14	综合判定：合格。

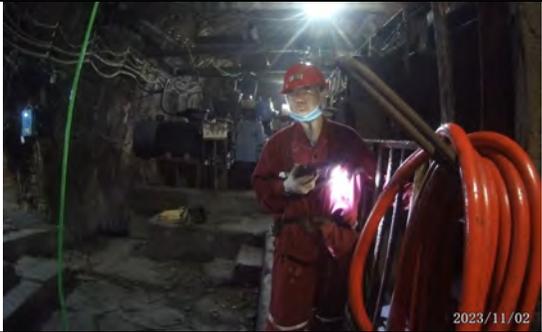
68	GX-B1416/22-2-23071	2023. 11. 14	综合判定：合格。

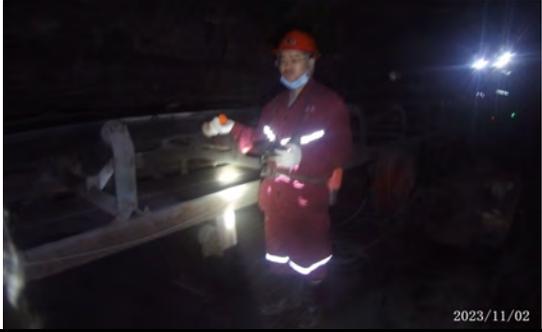
69	GX-B1416/22-2-23072	2023. 11. 14	综合判定：合格。

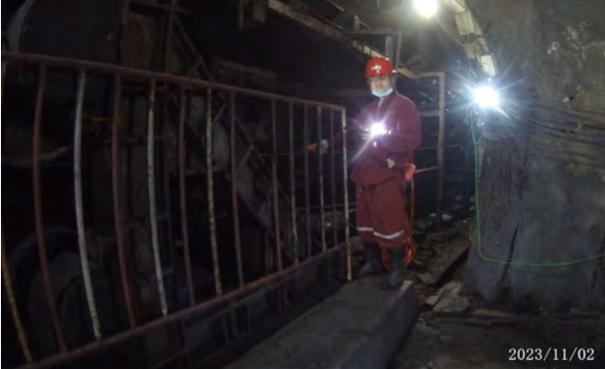
70	GX-B1416/22-2-23073	2023. 11. 14	综合判定：合格。

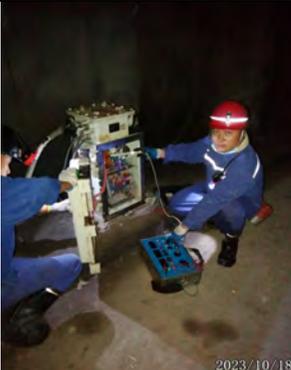
89	GX-B1359/21-2-23057~23058	2023/11/16	本次共检矿用隔爆型照明信号综合保护装置2台,2台所检项目合格。

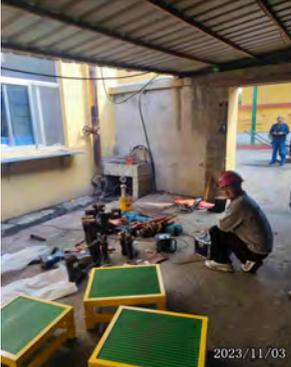
<p>2023/10/18</p>	
90	GX-B1328/20-2-23163	2023/11/16	本次共检绝缘手套30双,30双所检项目合格。

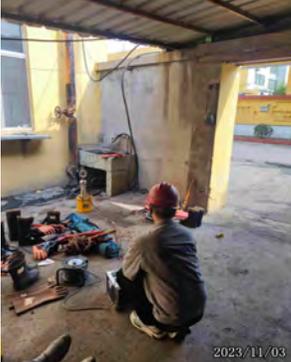
<p>2023/11/03</p>	
91	GX-B1328/20-2-23164	2023/11/16	本次共检绝缘鞋52双,52双所检项目合格。

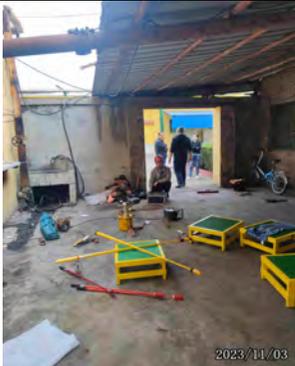
92	GX-B1328/20-2-23165	2023/11/16	本次共检验电器20支， 20支所检项目合格。

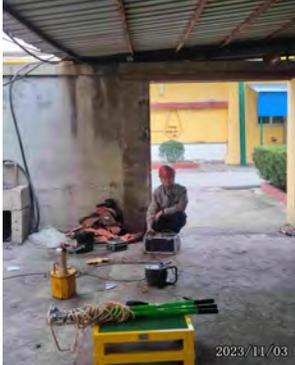
<p>2023/11/03</p>
93	GX-B1328/20-2-23166	2023/11/16	本次共检便携式接 地和接地短路装置 10组，10组所检项目合 格。

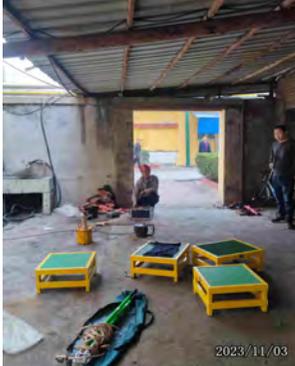
<p>2023/11/03</p>
94	GX-B1328/20-2-23167	2023/11/16	本次共检绝缘胶垫 4块，4块所检项目合格 。

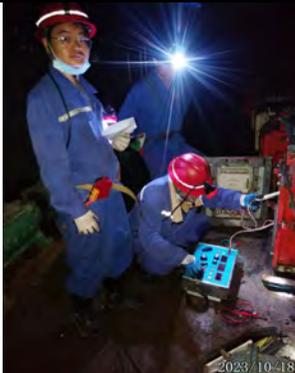
100	GX-B1352/21-2-23177~23187	2023. 11. 20	本次共检矿用防爆低压交流真空馈电开关11台, 11台所检项目合格。

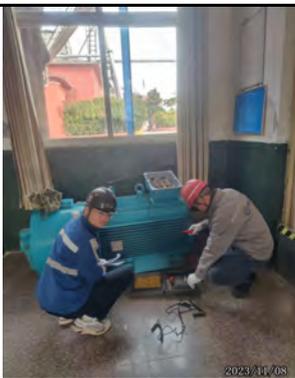
101	GX-B1323/21-2-23142~23149	2023. 11. 20	本次共检三相交流电动机8台，8台三相交流电动机所检项目合格。

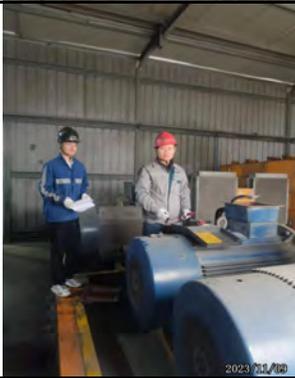
<p>2023/11/08</p>
102	GX-B1323/21-2-23150~23156	2023. 11. 20	本次共检三相交流电动机7台，7台三相交流电动机所检项目合格。

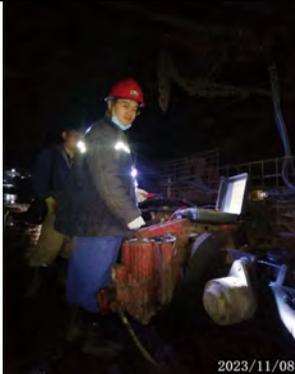
<p>2023/11/08</p>
103	GX-B1323/21-2-23157~23171	2023. 11. 20	本次共检三相交流电动机15台，15台三相交流电动机所检项目合格。

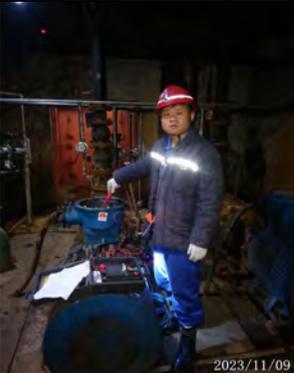
104	GX-B1323/21-2-23172~23179	2023. 11. 20	本次共检三相交流电动机8台，8台三相交流电动机所检项目合格。

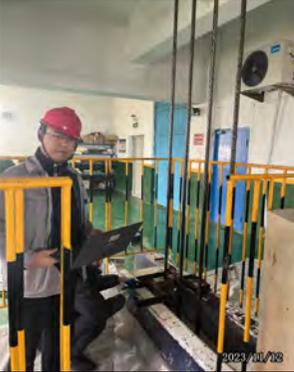
105	GX-B1598/21-2-23146	2023. 11. 21	实测钢丝绳有效截面积损失百分比最大为0.91%，小于5%为正常。

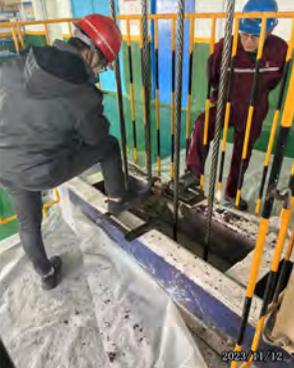
106	GX-B1598/21-2-23147	2023. 11. 21	实测钢丝绳有效截面积损失百分比最大为0.69%，小于5%为正常。

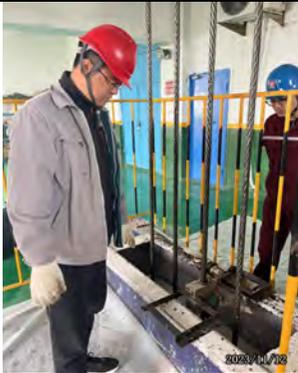
107	GX-B1598/21-2-23148	2023. 11. 21	<p>实测钢丝绳有效截面积 损失百分比最大为 0.81%，小于5%为正常 。</p>

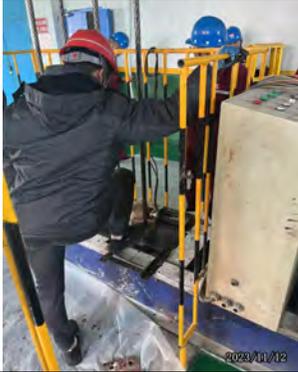
108	GX-B1598/21-2-23149	2023. 11. 21	<p>实测钢丝绳有效截面积 损失百分比最大为 0.75%，小于5%为正常 。</p>

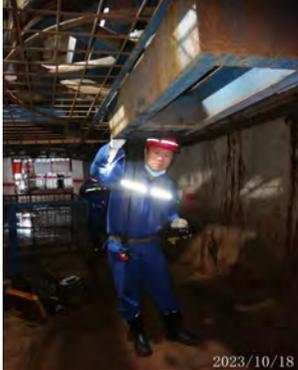
109	GX-B1310/21-2-23365	2023. 11. 19	<p>未发现超过Φ2mm当量 直径的缺陷。</p>
