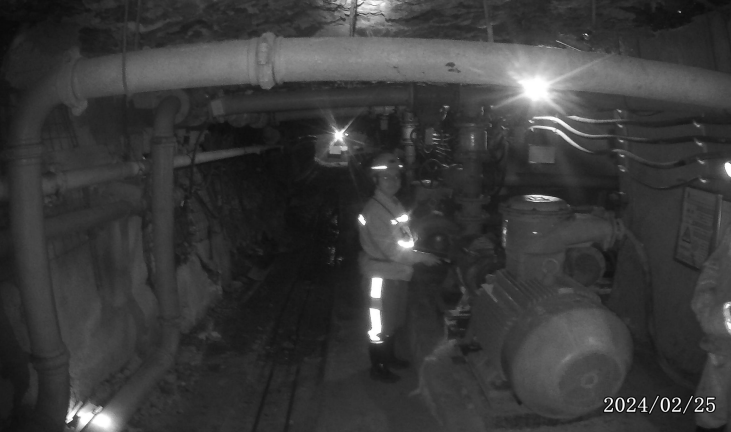
12	GX-B1499/23-2-24001	2024/3/12	除吨水百米电耗超限外，其余所检项目合格。 吨水百米电耗大于0.5 kW·h。

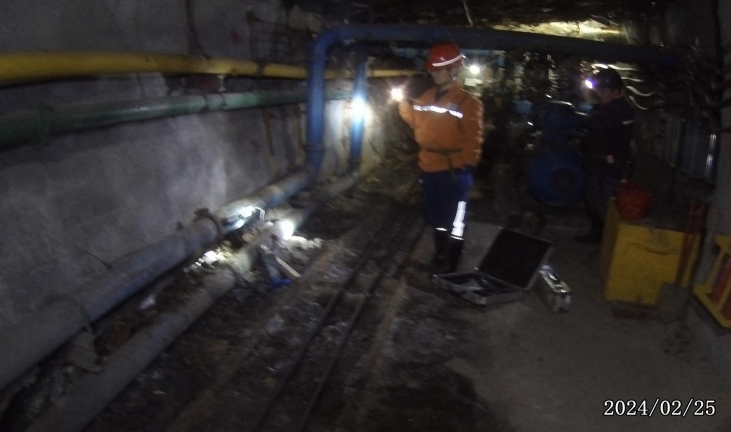
<p>2024/02/25</p>
13	GX-B1499/23-2-24002	2024/3/12	除吨水百米电耗超限外，其余所检项目合格。 吨水百米电耗大于0.5 kW·h。

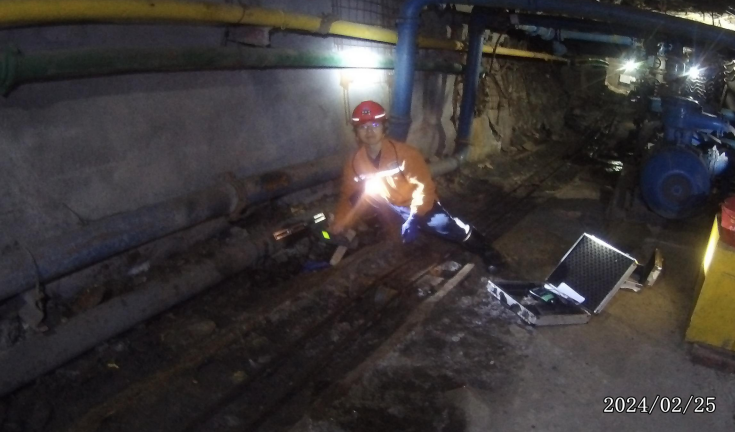
14	GX-B1499/23-2-24003	2024/3/12	除吨水百米电耗超限外，其余所检项目合格。 吨水百米电耗大于0.5 kW·h。

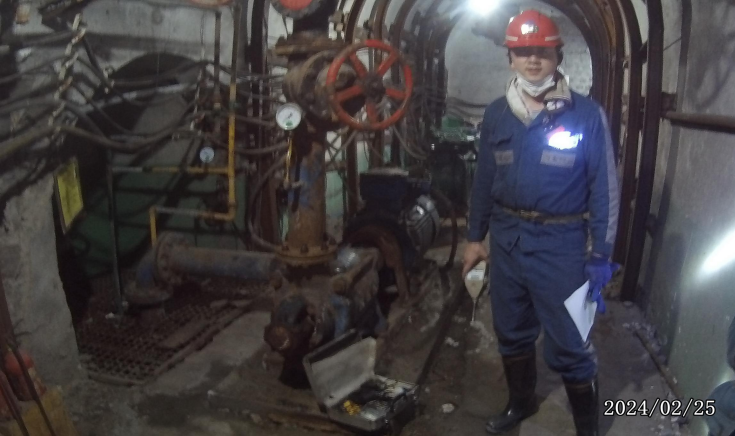
<p>2024/02/25</p>
15	GX-B1499/23-2-24004	2024/3/12	除吨水百米电耗超限外，其余所检项目合格。 吨水百米电耗大于0.5 kW·h。

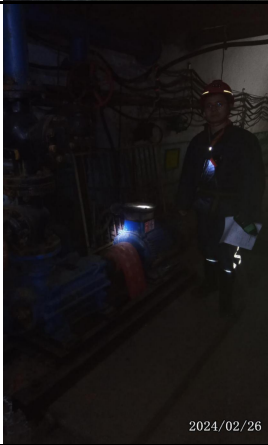
18	GX-B1499/23-2-24007	2024/3/12	除吨水百米电耗超限外，其余所检项目合格。 吨水百米电耗大于0.5 kW•h。		 	
19	GX-B1499/23-2-24008	2024/3/12	除吨水百米电耗超限外，其余所检项目合格。 吨水百米电耗大于0.5 kW•h。

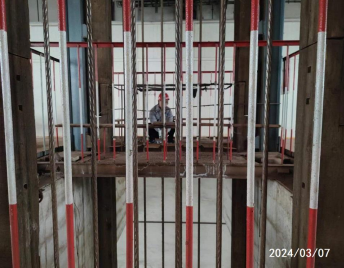
<p>A photograph showing a worker in a red safety vest and white shirt standing on a metal platform inside a vertical shaft. The worker is inspecting a steel cable. The shaft is lined with concrete and has several vertical steel rods. A red safety railing is visible in the foreground. A date stamp '2024/03/07' is in the bottom right corner.</p>
29	GX-B1598/21-2-24034	2024. 3. 15	实测钢丝绳有效截面积损失百分比最大为1.32%，小于5%为正常。 。
