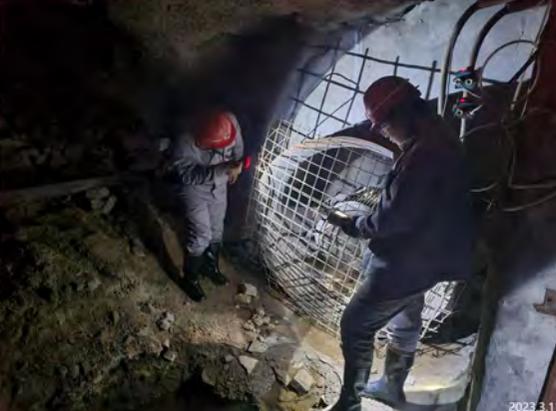
10	GX-B1341/21-9-23037	4.13	综合判定：合格

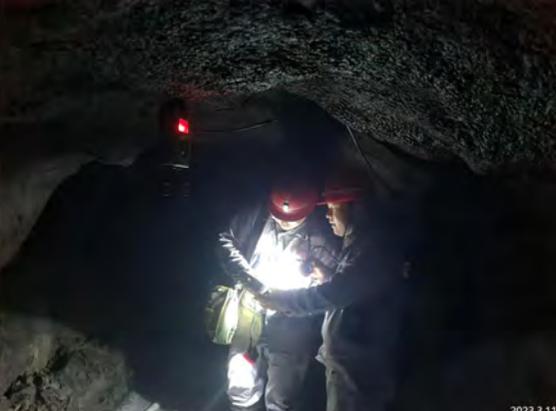
A photograph showing two workers in a dark tunnel. One worker is on the left, and another is on the right, both wearing hard hats and work clothes. They are working on a large, circular wire mesh structure that is being installed or inspected. The tunnel walls are rough and rocky. A timestamp '2023.3.11' is visible in the bottom right corner of the photo.	
11	GX-B1341/21-9-23038	4.13	综合判定：合格

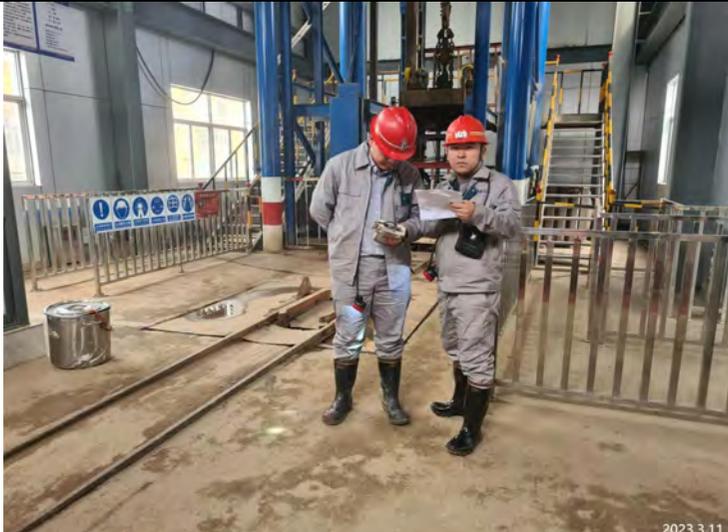
<p>2023.3.11</p>
13	GX-B1347/21-9-23007	4.13	<p>1. 风量（风速）合格率：100%，大于65%，合格；</p> <p>2. 风质合格率：100%，大于90%，合格；</p> <p>3. 作业环境空气质量合格率：100%，大于60%，合格；</p> <p>4. 矿井有效风量率66.2%，大于60%，合格；</p> <p>5. 风机全压效率为70.4%，大于70%，合格；</p> <p>6. 风量供需比1.63，符合$1.32 \leq \beta \leq 1.67$要求，合格；</p> <p>7. 综合指标88.1%，大于72%，合格。</p>

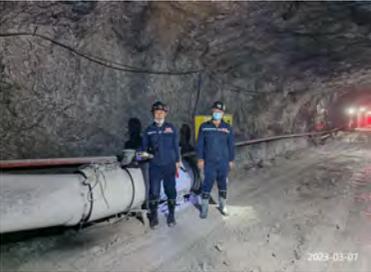
14	GX-B1594/21-9-23008	2023年4月13日	该局部通风机共检5项，除流量、全压不判定外，其他所检项目均合格。

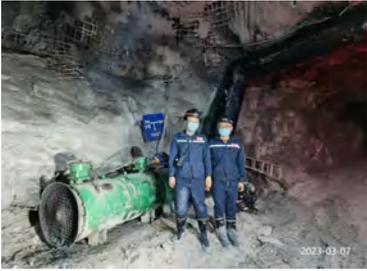
A photograph showing two workers in blue uniforms and hard hats standing in a tunnel. They are positioned next to a large, white, cylindrical object, likely a fan or part of the ventilation system. The tunnel walls are dark and rocky, and there are some cables and pipes visible in the background. A date stamp '2023-03-07' is visible in the bottom right corner of the image.
15	GX-B1594/21-9-23009	2023年4月13日	该局部通风机共检5项，除流量、全压不判定外，其他所检项目均合格。

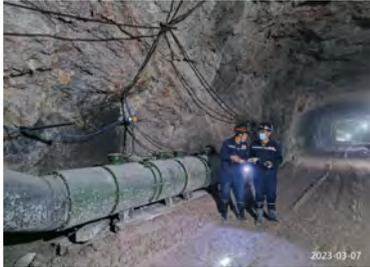
16	GX-B1594/21-9-23010	2023年4月13日	该局部通风机共检5项，除流量、全压不判定外，其他所检项目均合格。

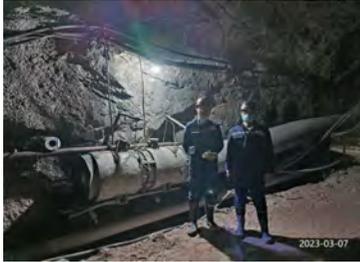
A photograph showing a large, green, cylindrical local fan in a dark tunnel. Two workers in blue uniforms and hard hats are standing next to the fan. The date '2023-03-07' is visible in the bottom right corner of the image.
17	GX-B1594/21-9-23011	2023年4月13日	该局部通风机共检5项，除流量、全压不判定外，其他所检项目均合格。
