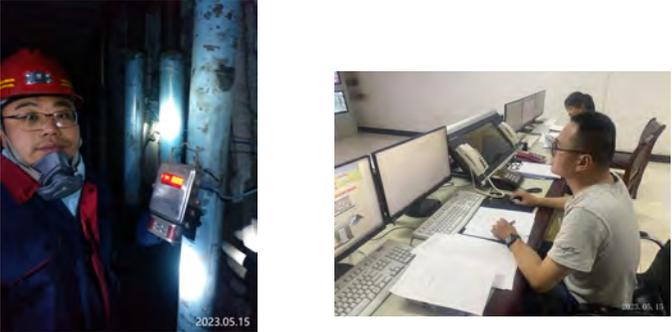
| 序号 | 报告编号 | 发布日期 | 结论 | 影像资料 |
|---|---|---|---|--|
| 1 | GX-B1370/21-8-23005 | 2023年6月2日 | <p>存在问题： 断电控制图中无甲烷传感器、馈电传感器等图例。 建议：加强甲烷超限断电闭锁和故障闭锁功能维护。除上述问题外，其余所检项目合格。</p> | |

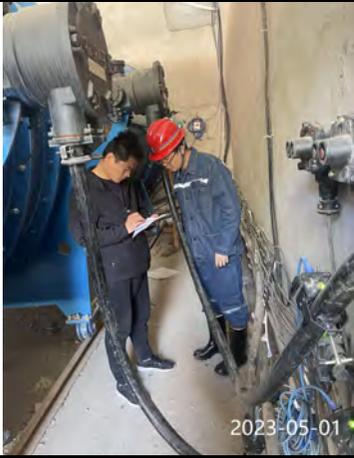
| 3 | GX-B1345/21-8-23006 | 2023年6月2日 | <p>核定矿井通风能力：50.6万吨/年。</p> <p>核定采掘工作面数：2个采煤工作面，1个备用工作面，4个掘进工作面。</p> | <p>2023-05-01</p> |

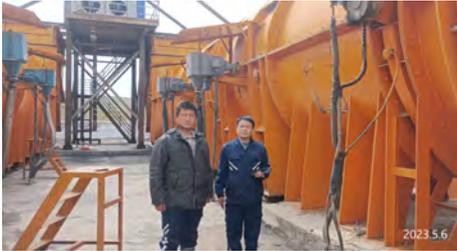
| 4 | GX-B1340/21-8-23044 | 2023年6月2日 | <p>该通风机在双级运行、叶片角度19.9° /17.8° 条件下，本次共测试5个频率运行状态（30Hz、35Hz、40Hz、45Hz、50Hz），所检项目合格。</p> | <p>2023.5.6</p> |

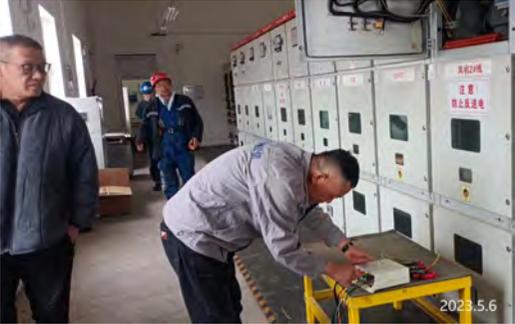
| 5 | GX-B1340/21-8-23045 | 2023年6月2日 | <p>该通风机在双级运行、叶片角度19.9° /17.8° 条件下，本次共测试5个频率运行状态（30Hz、35Hz、40Hz、45Hz、50Hz），所检项目合格。</p> | |

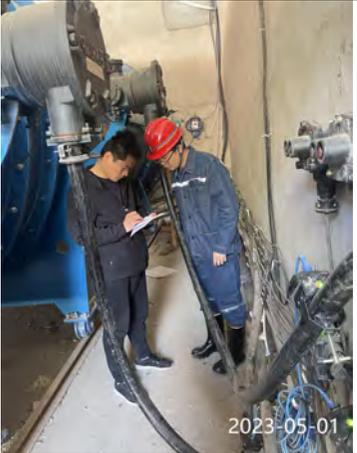
| 6 | GX-B1340/21-8-23038 | 2023年6月2日 | <p>该通风机在双级运行、叶片角度0° /0° 条件下，本次测试3个运行频率状态（35Hz、40Hz和50Hz），所检项目合格。</p> | |

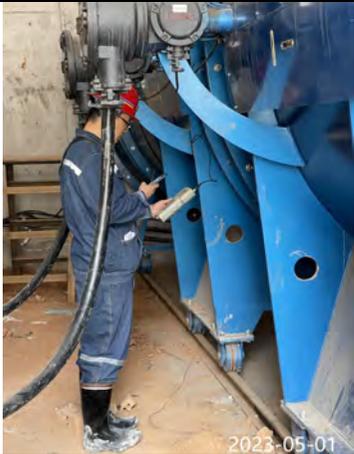
| 7 | GX-B1340/21-8-23039 | 2023年6月2日 | 该通风机在双级运行、叶片角度0° /0° 条件下，本次测试3个运行频率状态（35Hz、40Hz和50Hz），所检项目合格。 | |

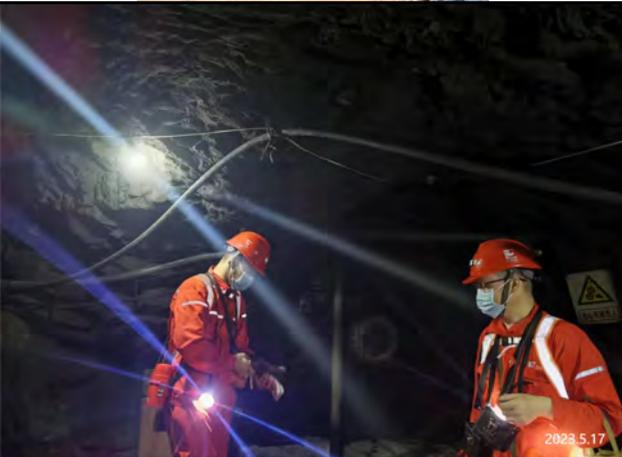
| 8 | GX-B1341/21-8-23019 | 2023年6月2日 | 综合判定：合格。 | |

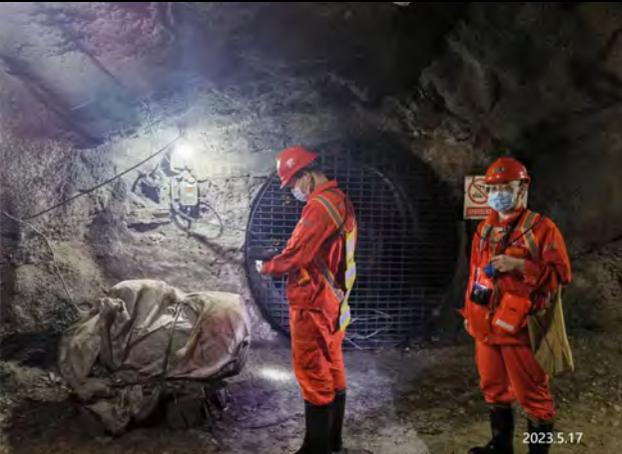
| 9 | GX-B1341/21-8-23020 | 2023年6月2日 | 综合判定：合格。 | A photograph showing two workers in orange safety suits and helmets inspecting a tunnel entrance. One worker is standing near a large metal grate, while the other is further back. The scene is dimly lit with a bright light source. A date stamp '2023.5.17' is visible in the bottom right corner of the image. |

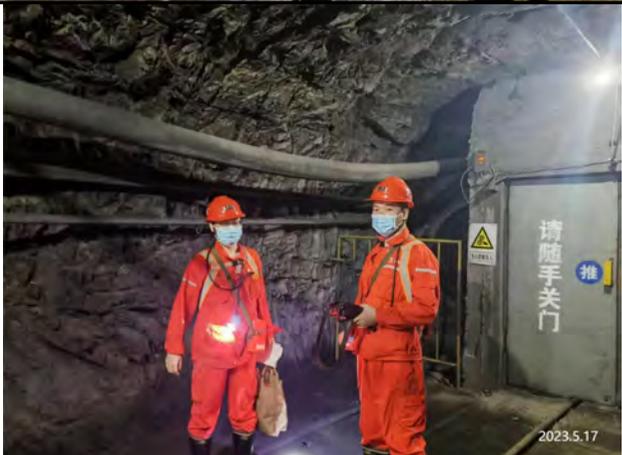
| 10 | GX-B1341/21-8-23021 | 2023年6月2日 | 综合判定：合格。 | A photograph showing two workers in orange safety suits and helmets standing near a tunnel entrance. They are positioned next to a metal door with a sign that reads '请随手关门' (Please close the door after use) and a blue '推' (Push) button. The scene is dimly lit with a bright light source. A date stamp '2023.5.17' is visible in the bottom right corner of the image. |

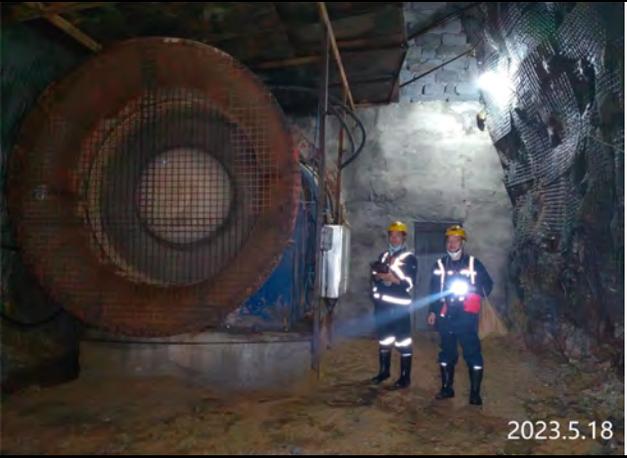
| 11 | GX-B1341/21-8-23024 | 2023年6月2日 | 综合判定：合格。 | |

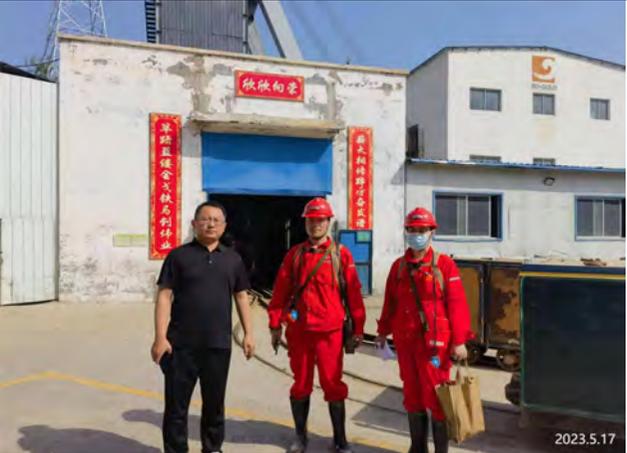
| 12 | GX-B1343/21-8-23009 | 2023年6月2日 | <p>1. 矿井总风量：7677.3m³/min；</p> <p>2. 主通风机风量：7900.2m³/min；</p> <p>3. 矿井有效风量：5329.9m³/min；</p> <p>4. 矿井有效风量率：67.5%；</p> <p>5. 机站风量：-420m中段主通风机 2409.6m³/min，-260m中段主通风机 2415.6m³/min，-180m中段主通风机 2394.0m³/min，风井-660m中段主通风机 681.0m³/min，混合井-660m中段主通风机 660.6m³/min；</p> <p>6. 机站风压：-420m中段主通风机840Pa；</p> <p>7. 矿井通风阻力：852.3Pa。</p> | |

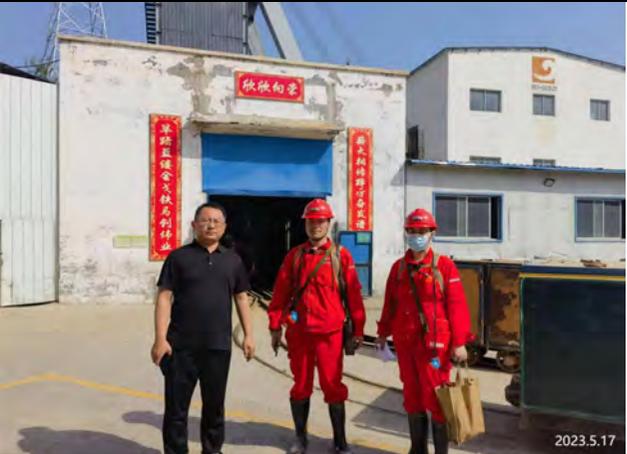
| 13 | GX-B1347/21-8-23009 | 2023年6月2日 | <p>1、风量（风速）合格率：100%，大于65%，合格；</p> <p>2、风质合格率：100%，大于90%，合格；</p> <p>3、作业环境空气质量合格率：100%，大于60%，合格；</p> <p>4、矿井有效风量率：67.5%，大于60%，合格；</p> <p>5、风机全压效率：73.5%，大于70%，合格；</p> <p>6、风量供需比：1.65，符合$1.32 \leq \beta \leq 1.67$要求，合格；</p> <p>7、综合指标：89.0%，大于72%，合格。</p> | |
