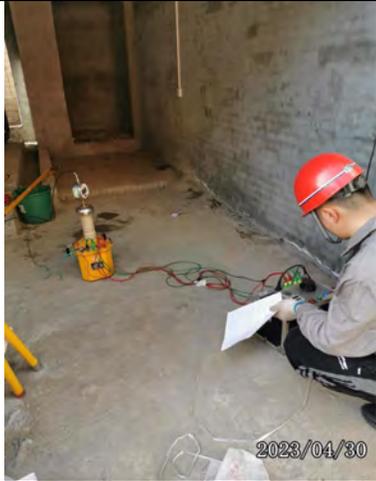
63	GX-B1328/20-2-23087	2023.6.5	所检项目合格。

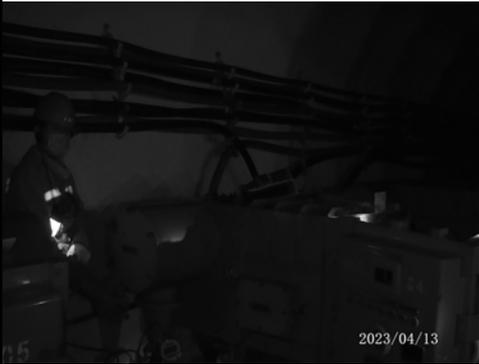
<p>2023/05/29</p>
79	GX-B1321/20-2-23188~23195	2023.6.6	所检项目合格

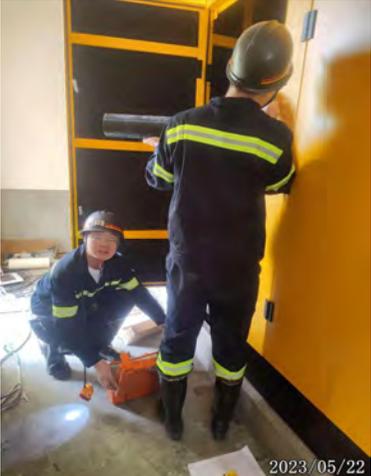
80	GX-B1307/20-2-23066	2023/6/6	综合判定：合格。

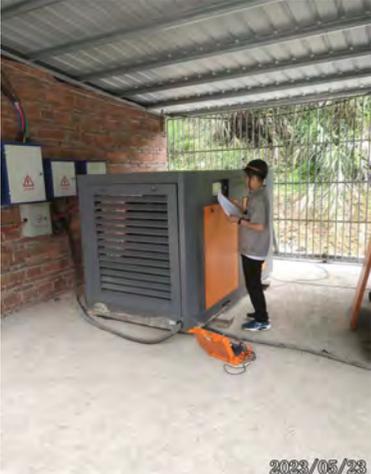
<p>2023/05/22</p>
81	GX-B1307/20-2-23063	2023.6.6	综合判定：合格。

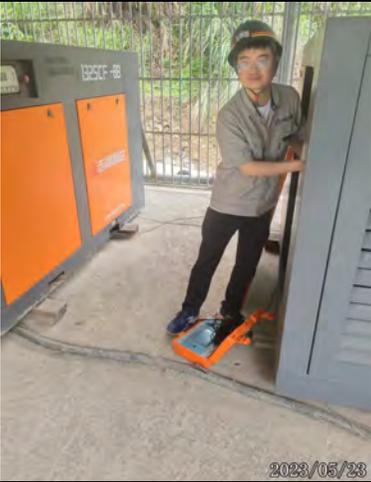
82	GX-B1307/20-2-23064	2023. 6. 6	综合判定：合格。

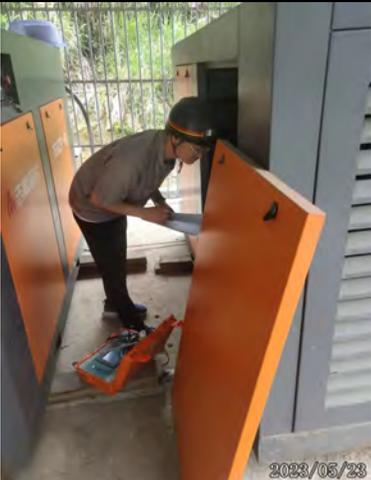
83	GX-B1307/20-2-23065	2023. 6. 6	综合判定：合格。

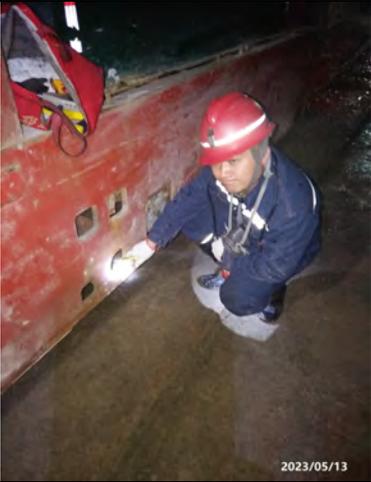
84	GX-B1517/20-2-23029	2023. 6. 7	综合判定：合格

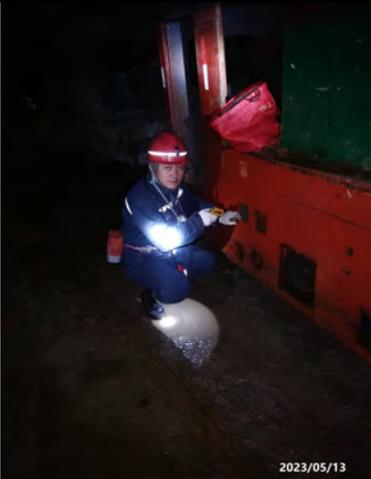
<p>2023/05/13</p>
85	GX-B1517/20-2-23030	2023. 6. 7	综合判定：合格

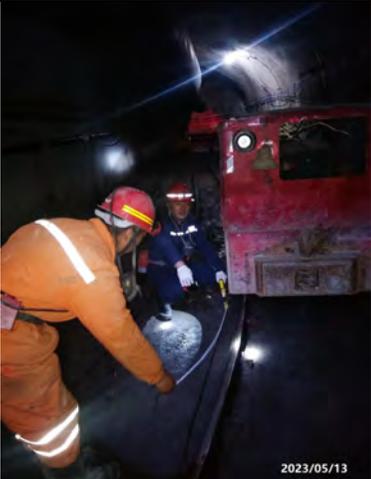
86	GX-B1517/20-2-23031	2023. 6. 7	综合判定：合格

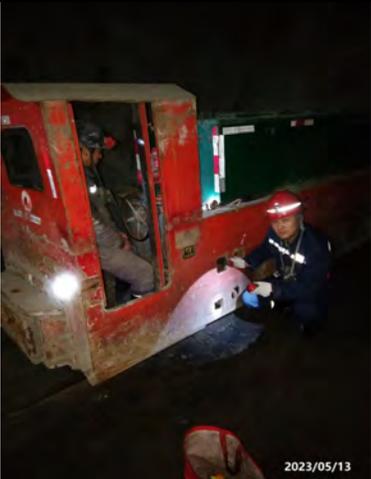
87	GX-B1517/20-2-23032	2023. 6. 7	综合判定：合格

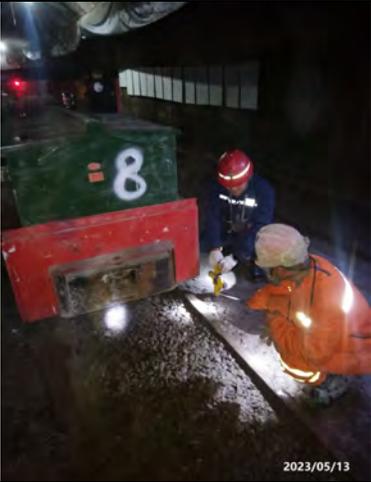
88	GX-B1517/20-2-23033	2023. 6. 7	综合判定：合格

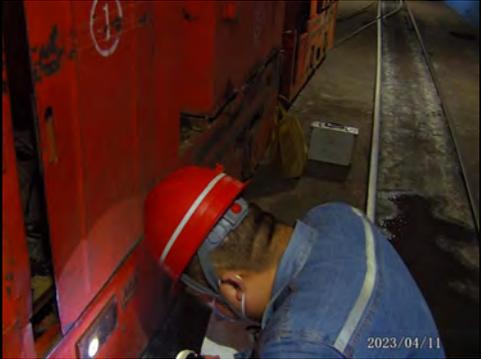
89	GX-B1517/20-2-23017	2023. 6. 7	综合判定：合格

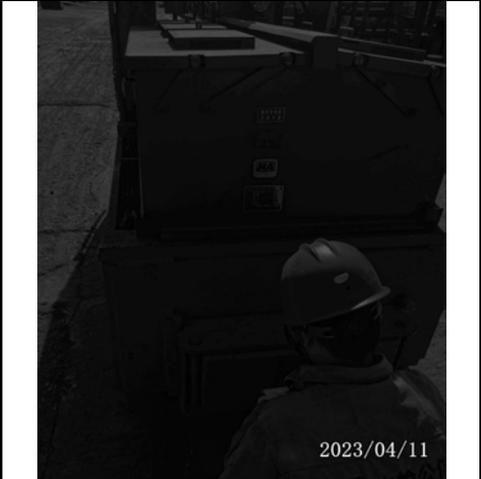
91	GX-B1517/20-2-23019	2023.6.7	综合判定：合格

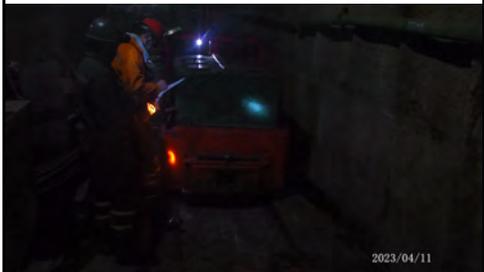
<p>2023/04/11</p>
93	GX-B1517/20-2-23021	2023. 6. 7	综合判定：合格

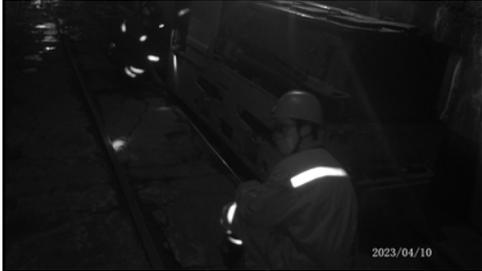
94	GX-B1517/20-2-23022	2023.6.7	综合判定：合格

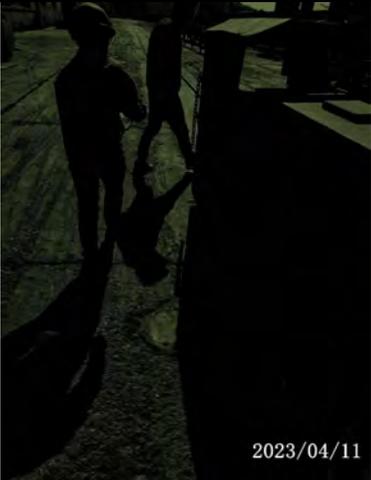
<p>2023/04/10</p>
95	GX-B1517/20-2-23023	2023.6.7	综合判定：合格

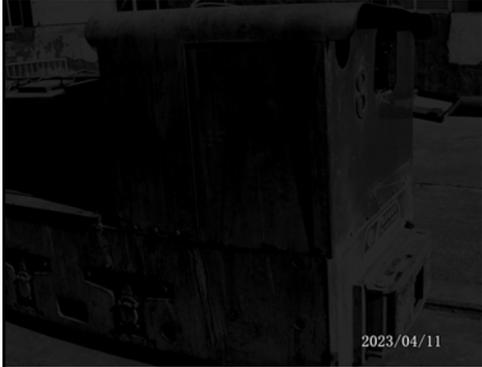
96	GX-B1517/20-2-23024	2023. 6. 7	综合判定：合格

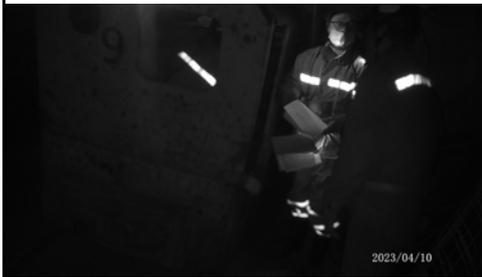
97	GX-B1517/20-2-23025	2023. 6. 7	综合判定：合格

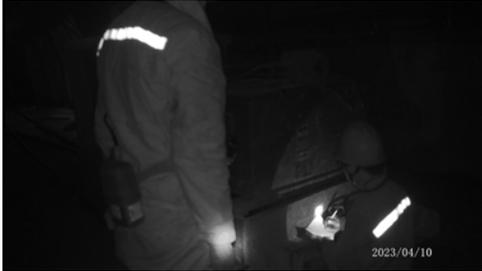
98	GX-B1517/20-2-23026	2023. 6. 7	综合判定：合格

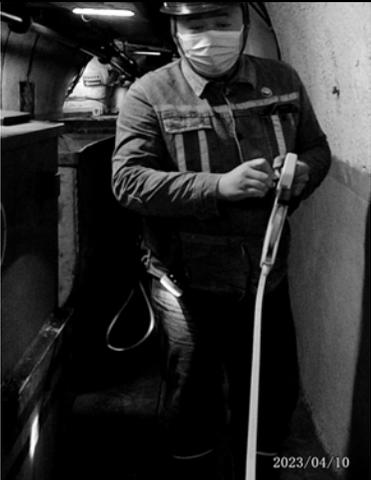
99	GX-B1517/20-2-23027	2023. 6. 7	综合判定：合格

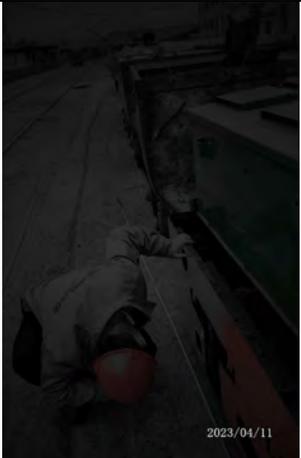
100	GX-B1517/20-2-23028	2023.6.7	综合判定：合格

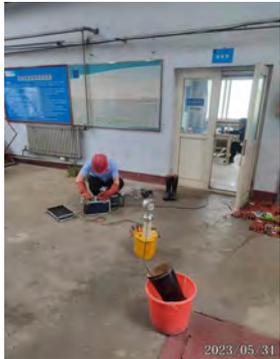
104	GX-B1328/20-2-23091	2023/6/7	本次共检绝缘鞋21双，21双所检项目合格。

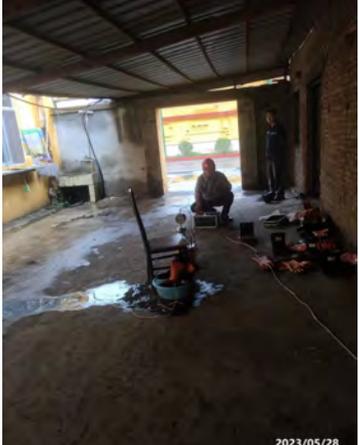
111	GX-B1328/20-2-23098	2023/6/7	本次共检绝缘手套30双，30双所检项目合格。

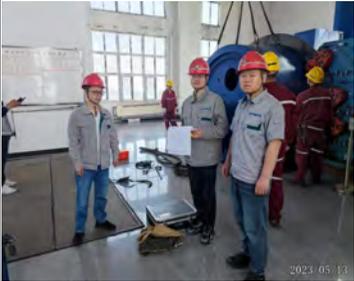
127	GX-B1301/21-2-23002	2023.6.8	综合判定：合格。

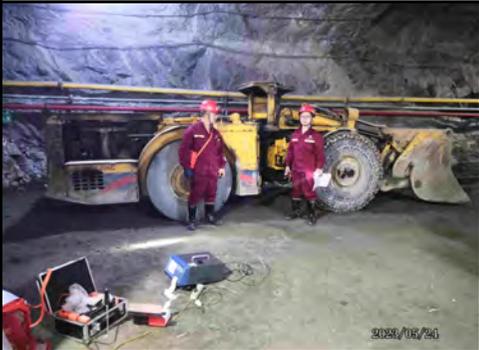
132	GX-B1574/20-2-23001	2023.6.7	所检项目合格。

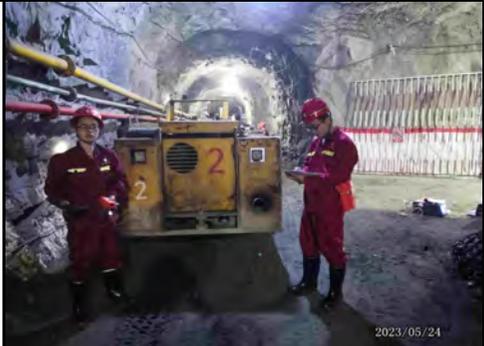
133	GX-B1574/20-2-23002	2023. 6. 7	所检项目合格。

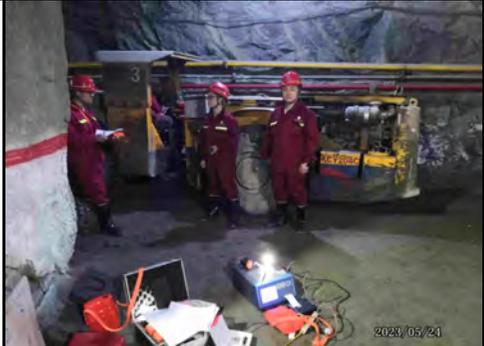
134	GX-B1574/20-2-23003	2023. 6. 7	所检项目合格。

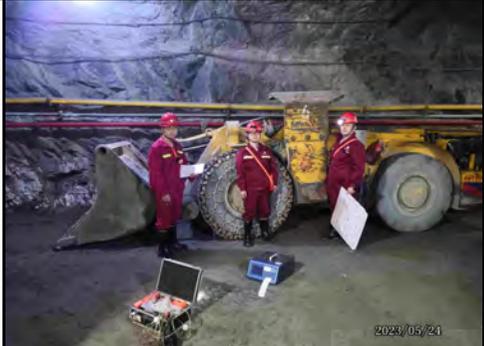
135	GX-B1574/20-2-23004	2023. 6. 7	所检项目合格。

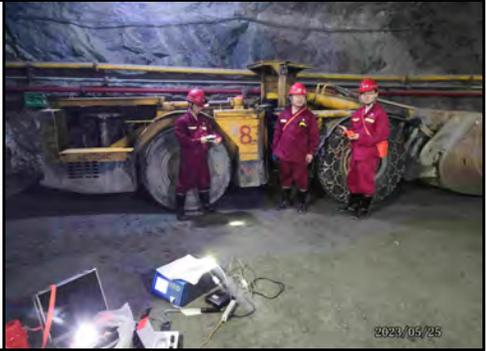
136	GX-B1574/20-2-23005	2023. 6. 7	所检项目合格。

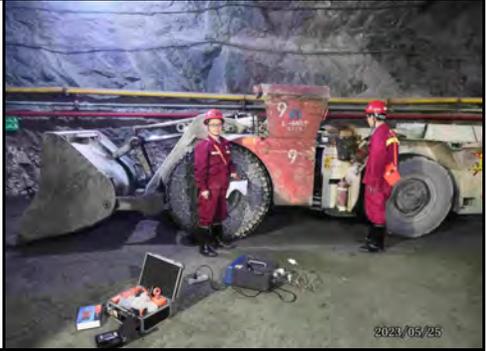
137	GX-B1574/20-2-23006	2023. 6. 7	所检项目合格。

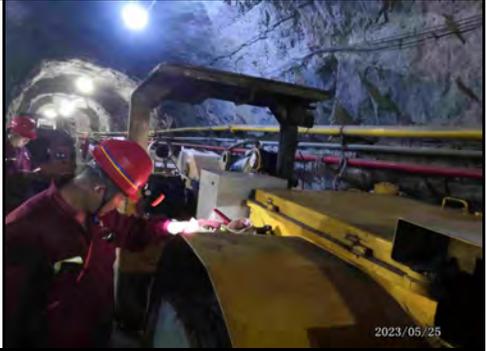
138	GX-B1574/20-2-23007	2023. 6. 7	所检项目合格。

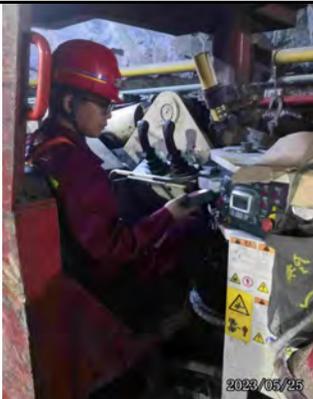
139	GX-B1574/20-2-23008	2023.6.7	所检项目合格。
